NO. S-246230  
VANCOUVER REGISTRY

**IN THE SUPREME COURT OF BRITISH COLUMBIA**

**AFFIDAVIT**

7. Attached hereto and marked as **Exhibit "A"** to this affidavit is a true copy of a targeted structural assessment I prepared and issued following a site visit on June 17, 2020 to assess the structural deterioration of the Townhomes, dated June 25, 2020.

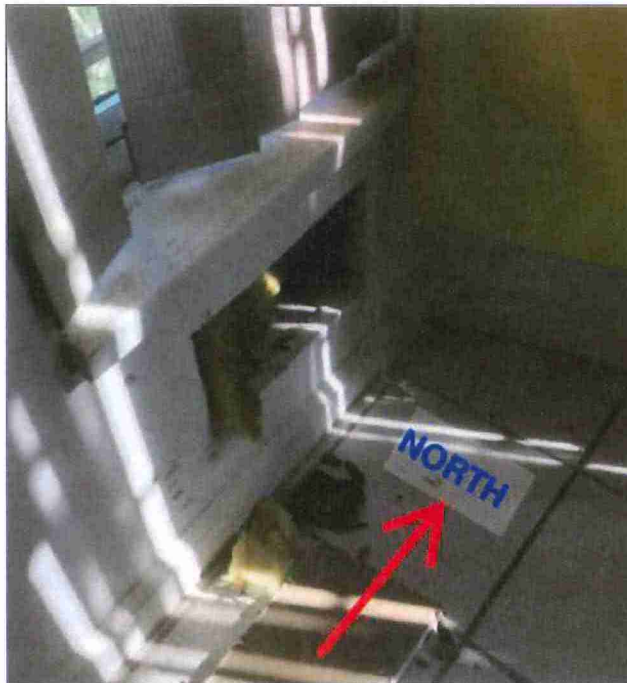
Figure 3

Findings were similar at all reviewed EOs: the plywood sheathing was deteriorated such that the interior face of the sheathing paper was visible and the bottoms of visible wood studs and the wood plates that they bear on were also deteriorated. Sheathing and framing deterioration was more advanced at the ground floor than the second floor. Figures 3 and 4 illustrate typical EOs.

*Typical Exploratory Opening, main floor, Unit 3368, first-floor enclosed balcony.*

*Deteriorated sheathing, which was removed from the EO, is visible on the floor.*

Due to the uncertainty associated with viewing structural framing members through the small EOs, we recommend that the Owners retain a structural engineer and contractor to remove GWB from the first and second floor enclosed balcony walls as required to permit an evaluation of the underlying wood framing. After the condition of the framing has been evaluated, a temporary shoring or repair procedure can be developed. This recommendation pertains to Units 3364 to 3374 (six units).

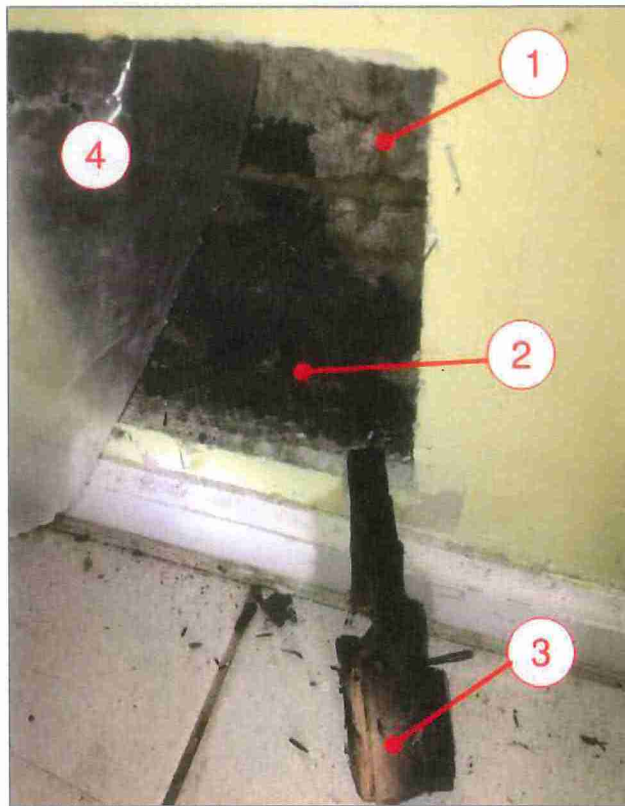
Figure 4

- 1) Interior surface of sheathing paper. The sheathing paper, which is on the exterior surface of the plywood sheathing, is visible because the plywood sheathing has deteriorated.
- 2) Deteriorated plywood sheathing.
- 3) A section of deteriorated wood stud that was pulled out of the EO.
- 4) Polyethylene vapour barrier

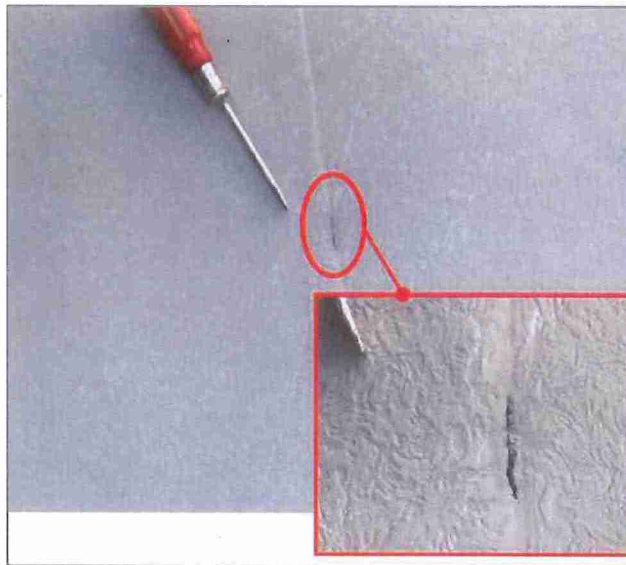
At all of the reviewed third-floor deck membranes, discontinuities at membrane seams were observed – refer to Figure 5 for example. The deck membrane at Unit 3370 has been patched, and it was apparent that the sheathing beneath the patch has deteriorated to the point that it can no longer support pedestrian traffic – refer to Figure 6. It is worthy of note that the architectural drawings indicate that each deck assembly includes a polyethylene vapour barrier, which is located on the top (hidden) surface of the GWB that forms the master bedroom ceilings. The vapour barrier may be protecting the ceiling GWB from water damage even if water is accumulating within the deck/ceiling assembly.

Third-floor deck at Unit 3368 with membrane discontinuity at seam. Similar observations were recorded at other third-floor decks.

All third-floor deck membranes should also be renewed. It is likely that once the existing membranes have been removed, damage to underlying wood framing will become apparent and will need to be addressed.

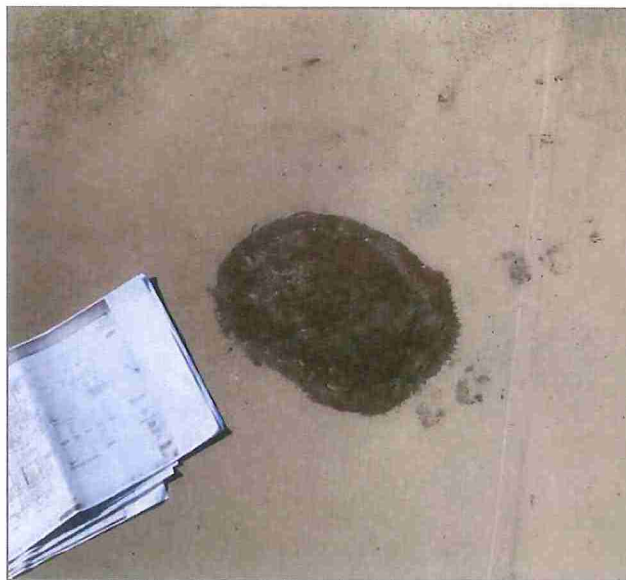
Figure 6

Third floor deck membrane patch at Unit 3370. The sheathing beneath the patch had deteriorated to the point that it can no longer support pedestrian traffic.

Access to this deck should be prohibited until permanent repairs have been completed due to potential life safety concerns.

Access to the third-floor deck at Unit 3370 should be prohibited until structural repairs have been completed.

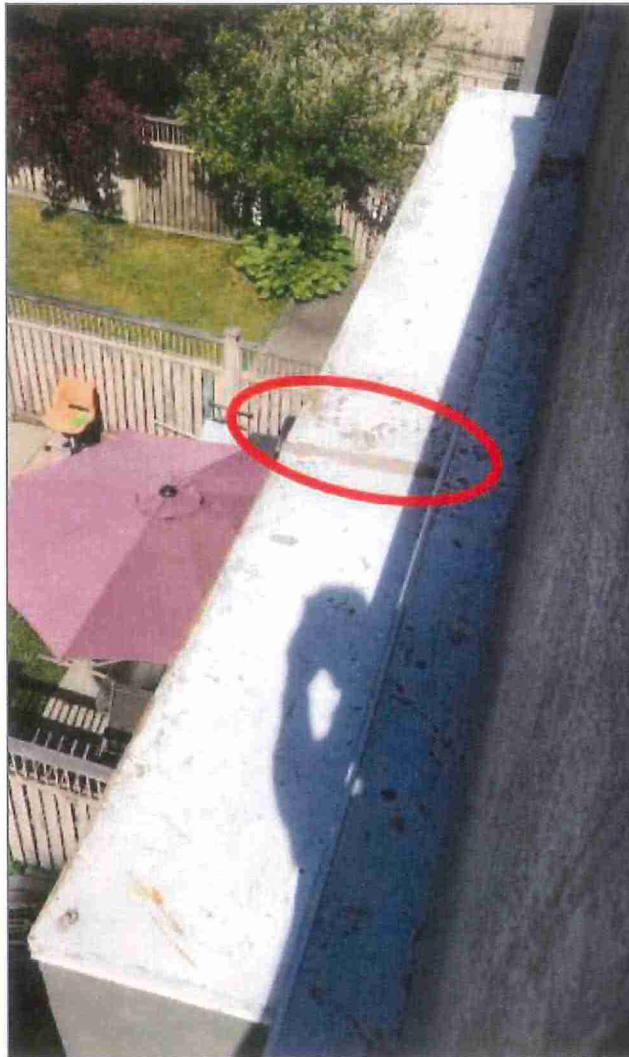
*Figure 7*

We noted numerous horizontal surfaces that are protected by metal cap flashings, which have been spliced. The splices rely on sealant to remain watertight – refer to Figure 7 for example. Our experience indicates that this type of sealant joint is generally not reliable.

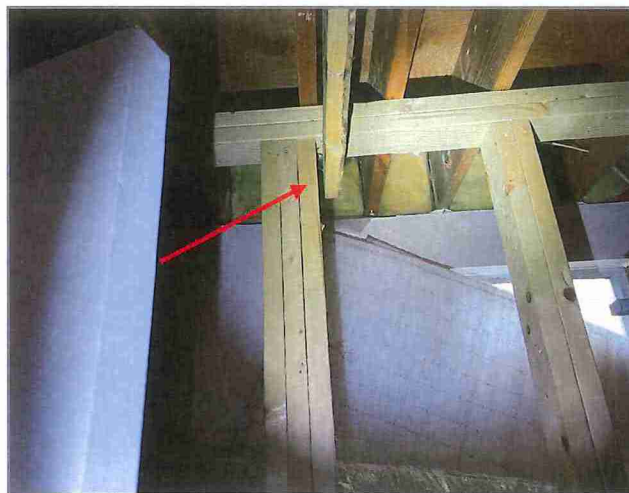
*Figure 1*  
Unit 3362 – Main floor shoring  
The arrow indicates the location of a loose brace.

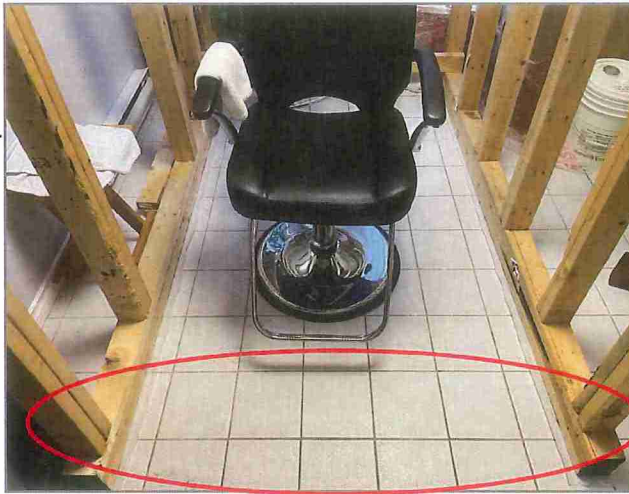
*Figure 2*  
Unit 3374 - Main floor shoring  
The red ellipse indicates the  
location of a missing brace.

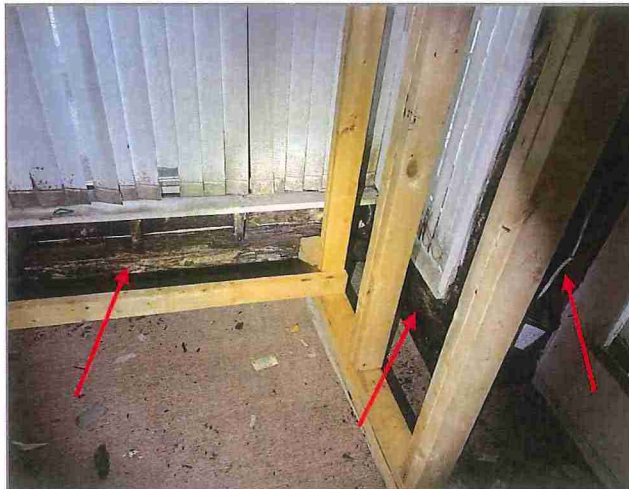
*Figure 3*  
Unit 3376 - Deteriorated  
exterior wall - main floor

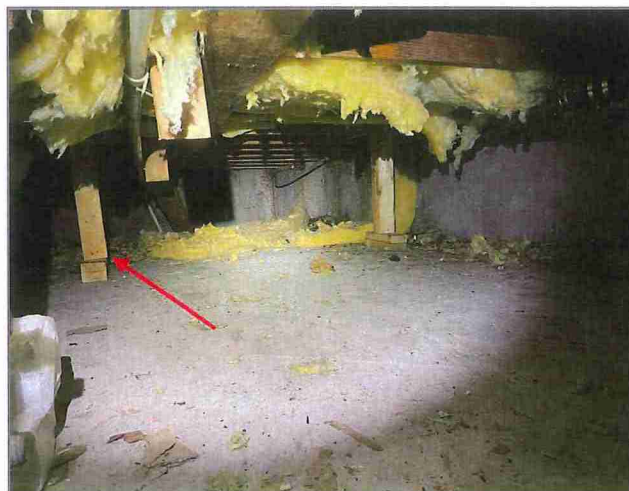
Unit 3376 Crawlspace Shoring supporting main floor	<p>One of the shoring posts appears to have moved and is no longer plumb or fully bearing on its supporting plate – refer to Figure 4.</p> <p><b>Recommendation:</b> Remove and reattach the affected shoring post as per drawing Shore – 7</p>

*Figure 4*  
Unit 3376 - Crawl space.  
Out of plumb post not fully  
bearing on the supporting  
plate (red arrow).

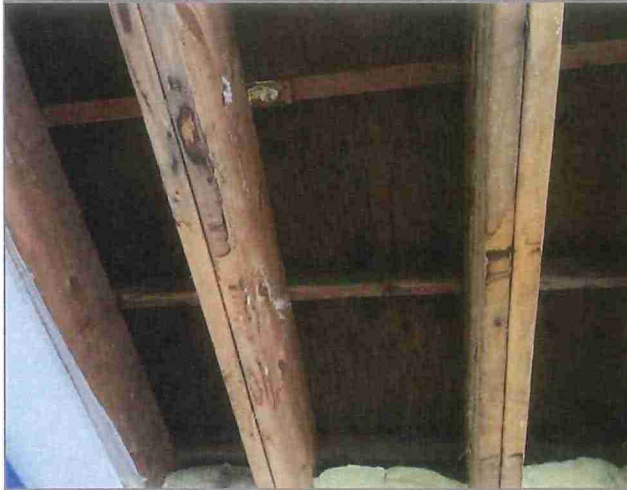
*Figure 3.4*

Localized staining and organic growth were observed on the 2x10 wood joists that support the third-floor deck (Figure 3.4). However, the existing 2x10 wood joists were generally free from significant deterioration and their structural integrity was not significantly compromised.

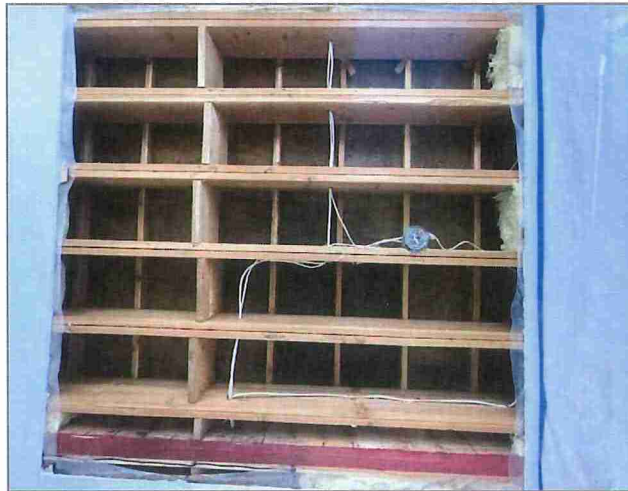
*Figure 3.7*

On August 25, 2023, RDH attended Unit 3366 to review the exploratory opening prepared by Steelhead in the room below the third-floor deck (Figure 3.7). RDH's observations at this exploratory opening were generally consistent with our observations at Unit 3372 and Unit 3376. The existing plywood sheathing showed evidence of deterioration and should not be relied on to support resident's use of the deck (Figure 3.8). However, the existing 2x10 wood joists were generally free from significant deterioration and their structural integrity was not significantly compromised.

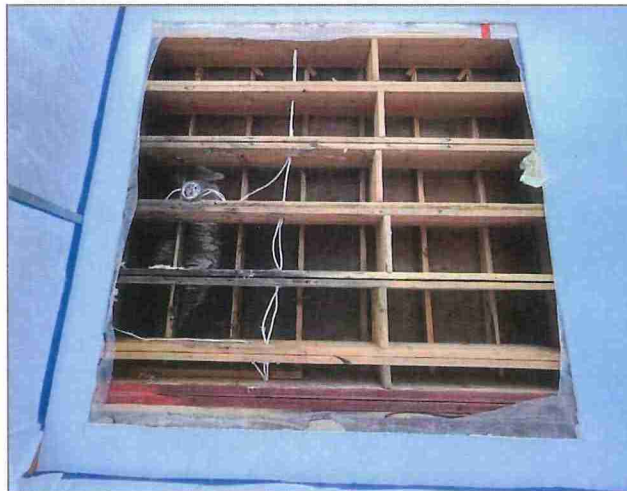
*Figure 3.9*

On August 28, 2023. RDH attended Unit 3364 to review the exploratory opening prepared by Steelhead in the room below the third-floor deck (Figure 3.9). RDH observed staining, organic growth, and significant deterioration of the existing plywood sheathing (Figure 3.10). The existing plywood sheathing was compromised and should not be relied on to support resident's use of the deck.

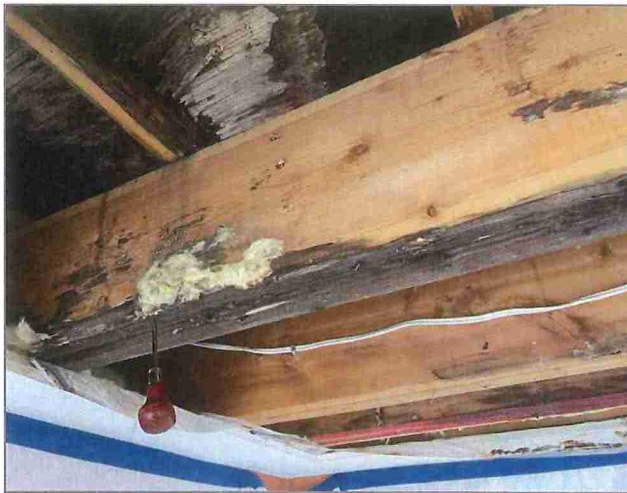
*Figure 3.11*

Localized staining, organic growth, and deterioration was observed on one of the double 2x10 wood joists that support the third-floor deck (Figure 3.11). The structural capacity of this damaged double 2x10 joist had been reduced which necessitated repairs. RDH provided repair instructions to Steelhead in the form of site sketches and verbal instructions. The repair involved applying preservative treatment to the existing damaged wood joist and sistering a new pressure treated 2x10 to the side of the damaged joist.
