IN THE SUPREME COURT OF BRITISH COLUMBIA

BUILDING ENVELOPE CONDITION ASSESSMENT REPORT

DATE:
 January 3, 2017

PROJECT: Joyce Place - Strata Plan LMS 992
Building Envelope Investigation

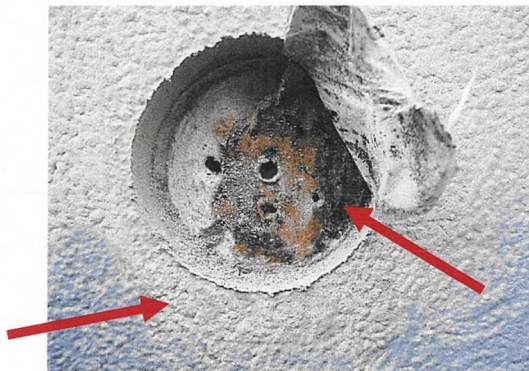
Photograph 26: Tower

ITEM	DESCRIPTION
7.0	EXPLORATORY OPENINGS ("EO")
7.3	Summary of Findings at the EO's
7.3.1	<p>A. Tower:</p> <p>MGH observed at the majority of EO locations that the paper cover on the gypsum sheathing board was stained by previous contact with moisture. However the gypsum core sandwiched between the paper appeared intact. At a few EO locations the gypsum sheathing was soft and deteriorated from previous contact with moisture behind the stucco cladding. See Photograph 26.</p>

View of an exploratory opening ("EO") on the West elevation, Level 6. The left arrow points to the stucco cladding. The right arrow points to a darkened moisture stain on the paper face of the gypsum sheathing board.

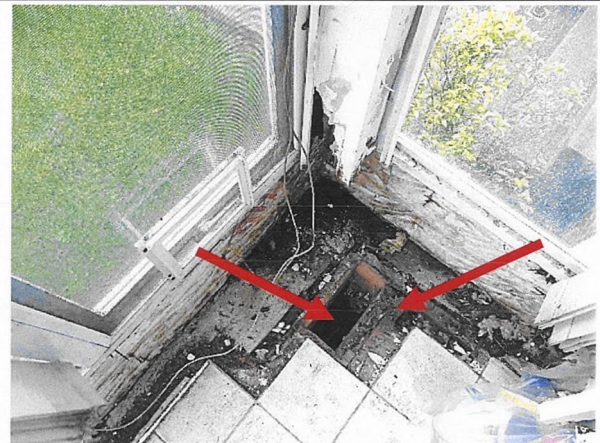
Photograph 27: Town Homes (#3362)

The left arrow points to a hole after removal of some of the decayed plywood floor board. The right arrow points to a decayed floor joist.

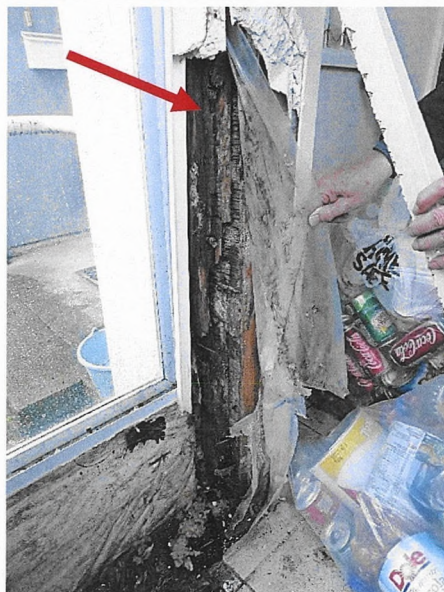
Photograph 28: Town Homes (#3362)

The arrow points to a decayed column. The extent of decay continues higher than the arrow.

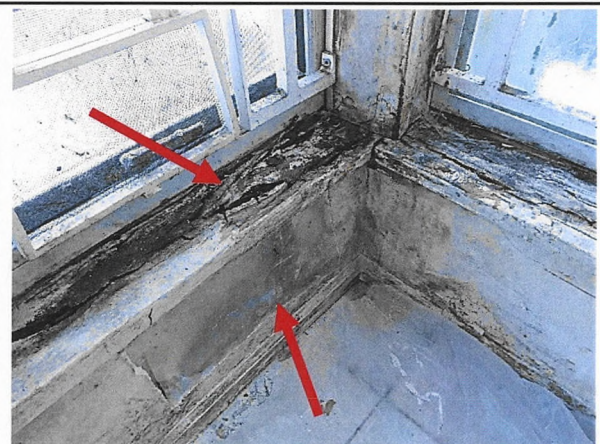
Photograph 29: Town Homes (#3376)

The left arrow points to fungal growth and severe decay of the wood stool plate. The right arrow points to the location of the EO in the interior drywall. See **Photograph 30**.

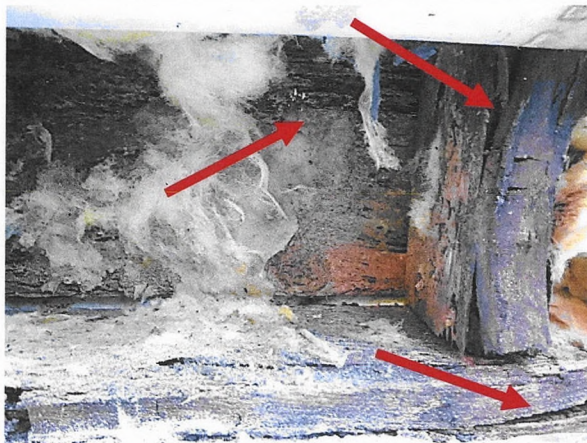
Photograph 30: Town Homes (#3376)

The top arrow points to the decayed wall stud. The middle arrow points to decayed plywood sheathing. The bottom arrow points to a decayed wall plate. See **Photograph 29**.

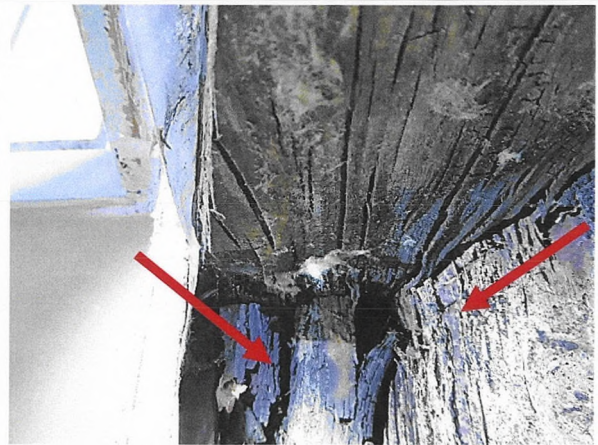
Photograph 31: Town Homes (#3364)

The left arrow points to severe decay at a corner column. The right arrow points to severe decay at the plywood sheathing board.

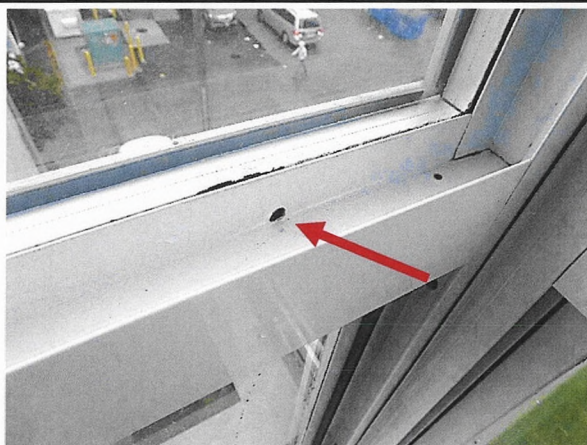
Photograph 32: Tower (#303)

The arrow points to an example of a weep-hole drilled (by other parties) into the window frame to drain water that accumulates in the upper horizontal trough of the frame. Similar weep-holes were added to other window at other units in the tower.

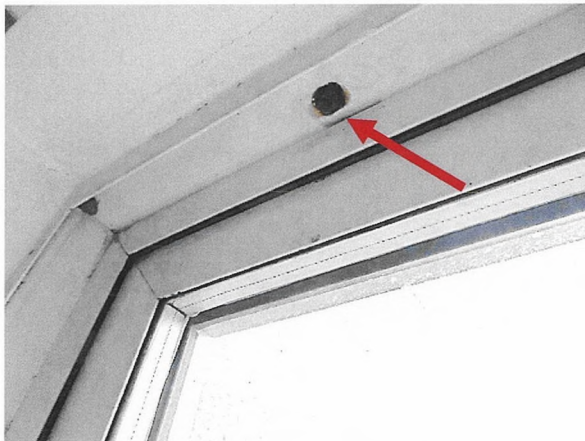
Photograph 34: Tower (#502)

The arrow points to a corroded screw that anchors the window frame to the building. Water actively leaks through these screw holes. See **Photograph 33**.

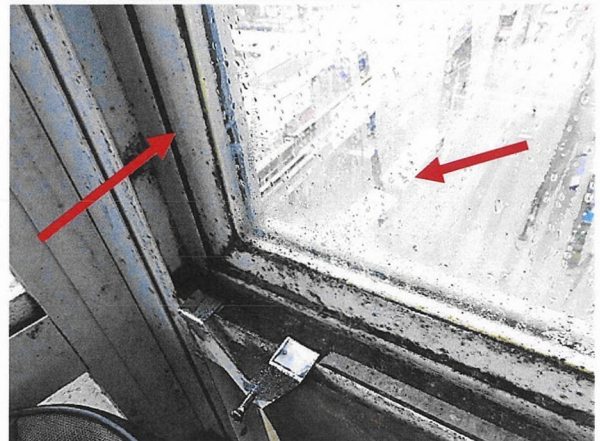
Photograph 35: Tower (#901)

The arrows point to severe condensation on the window glass and window frames. The water runs down the window and accumulates in the troughs of the window frame on the wood stool plate along the window sill.

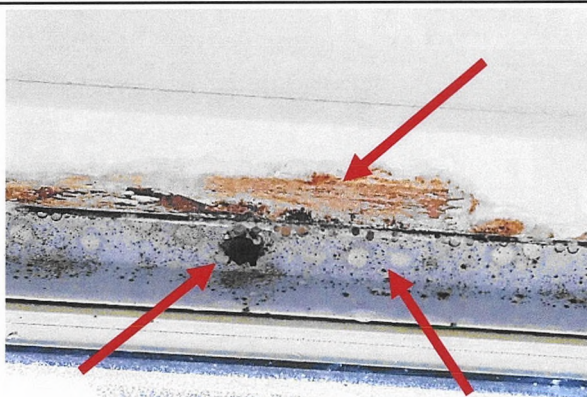
Photograph 36: Tower (#901)

The left arrow points to a corroded fastener. The middle arrow points to saturated/decayed wood surrounding the window. The right arrow points to multiple large water droplets hanging along the head of the window frame.

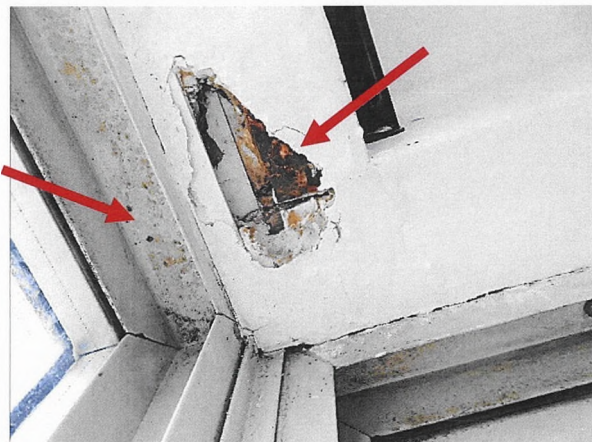
Photograph 40: Tower (#1006)

View at the ceiling above the windows in the enclosed balcony. The left arrow points to water stains from previous condensation along the head of the window frame. The right arrow points to corrosion on the metal components behind the interior drywall assembly.

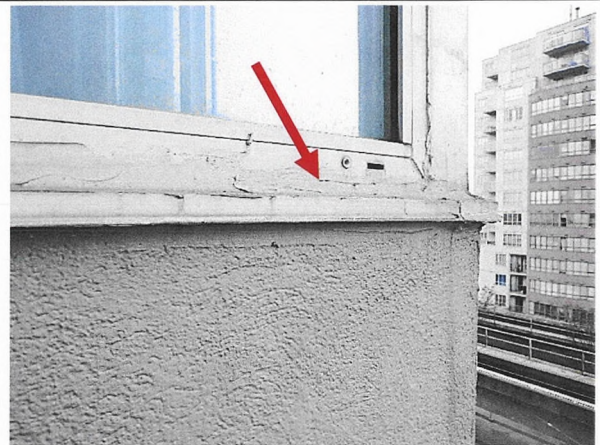
Photograph 43: Tower
 .The arrow points to caulking at exterior joints of a typical window. The caulking appears weathered.

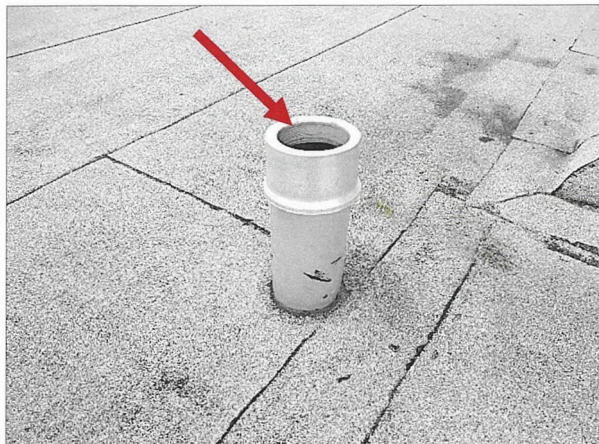
Photograph 46: Tower

The arrow points to a typical plumbing stack at the upper flat roof. The end of the pipe is open to the air. Install a mesh screen across the open end to prevent access to insects and rodents.

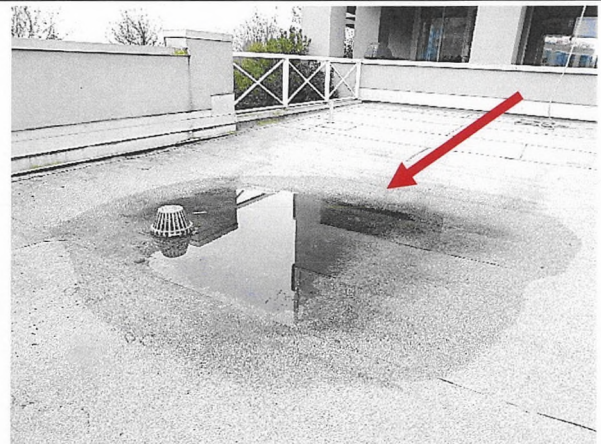
Photograph 47: Tower

The left arrow points to 1 of 2 roof drains on the lower flat roof (floor level 2). The right arrow points to the outline of one the two large areas of standing water surrounding the roof drains.

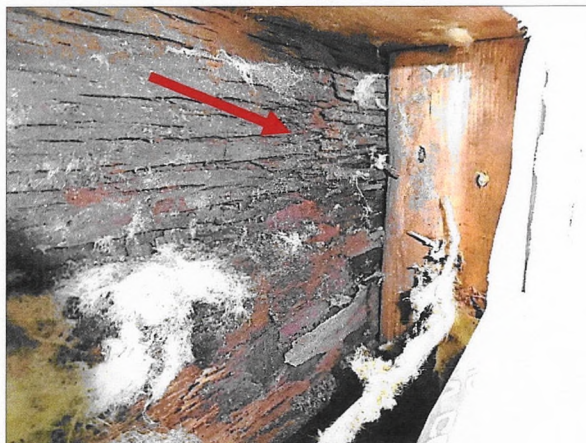
Photograph 48: Town Homes (#3372)

The arrow points to severe decay of the plywood sheathing board at the North exterior wall. The source of moisture is likely water from condensation on the window frame above the wall. See **Photograph 49**.

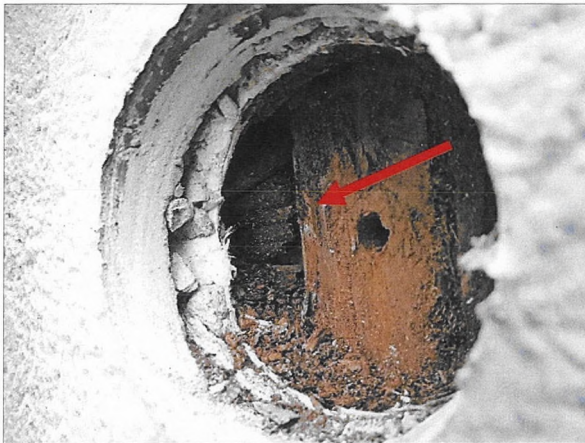
Photograph 50: Town Homes (#3362)
 EO made at the North elevation, on a narrow East facing wall at floor level 2, below a horizontal joint. The arrow points to decayed plywood sheathing board.

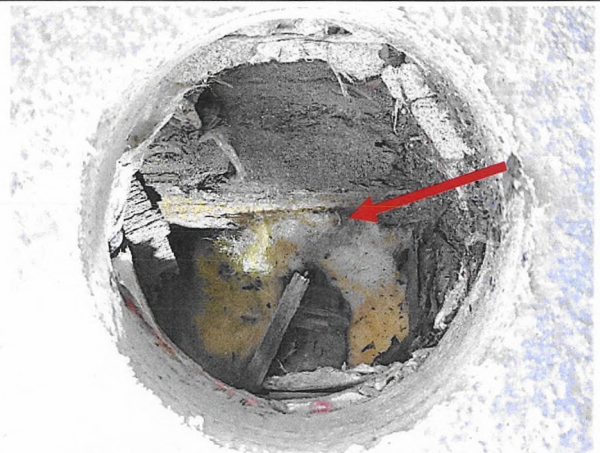
Photograph 51: Town Homes (#3362)
 EO made at the narrow West facing wall at floor level 2, below the bottom corner of a window. The arrow points to decayed plywood sheathing board.

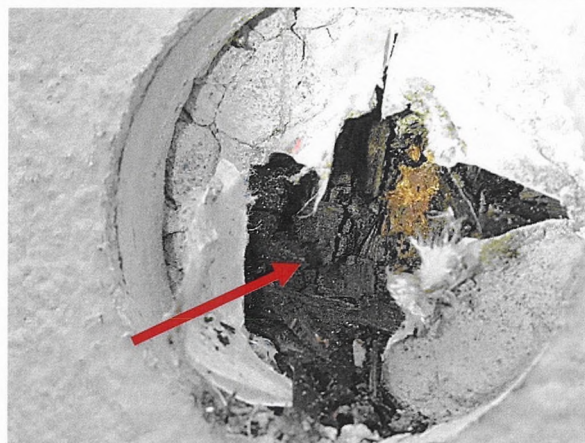
Photograph 52: Town Homes (#3366 / #3368)
 EO made at the narrow face of a wall that divides 2 adjacent balconies at floor level 2. The arrow points to decayed plywood sheathing board.

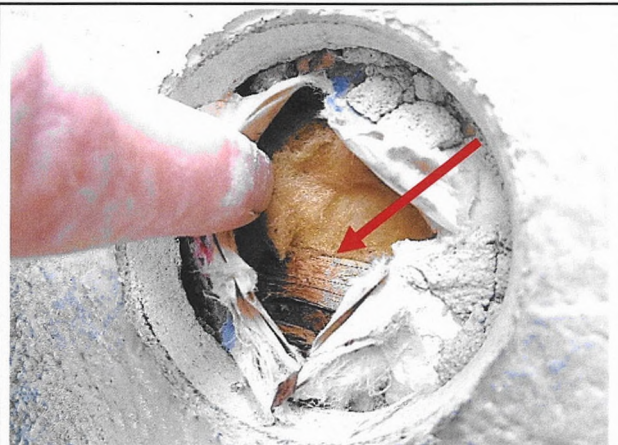
Photograph 53: Town Homes (#3376)
 EO made at the narrow wall facing South at floor level 2, below a horizontal joint. The arrow points to decayed plywood sheathing board.

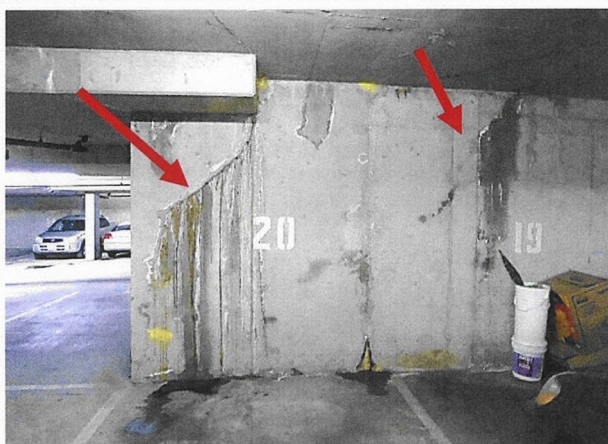
Photograph 56: Parkade

The arrows point to active leaks through the foundation wall. West end of the parkade.

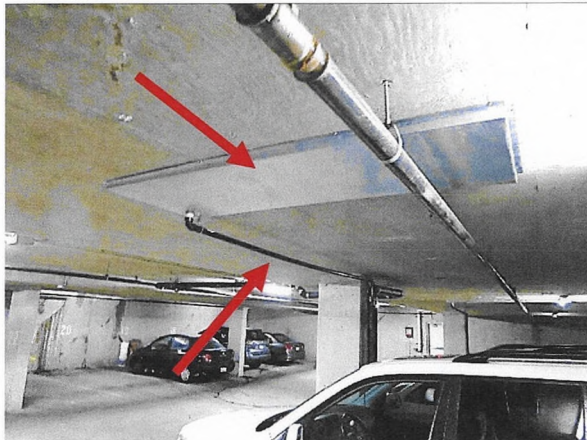
Photograph 58: Parkade

The upper arrow points to a typical pan/tray at the underside of the parkade roof slab to catch water leaking through cracks in the slab. The lower arrow points to a drain pipe that discharges the water to the parkade floor.

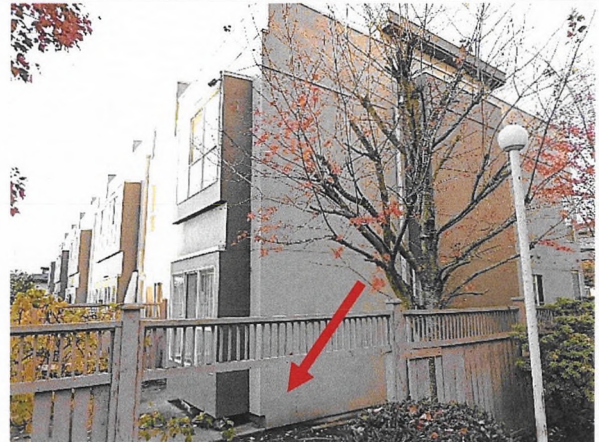
Photograph 59: Fence

View of the fence separating the tower and the town homes. The arrow points to 1 of 2 locations where large areas of the fence panels are missing.

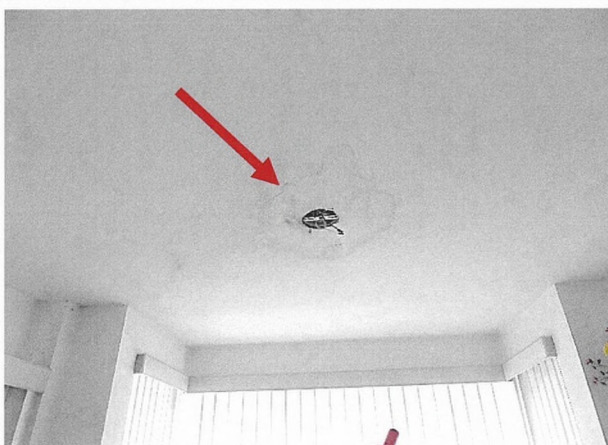
Photograph 60: Town Homes (#3376)

The arrow points to a moisture stain surrounding the junction box for a light fixture. The stain was not wet at the time of MGH's site visit. The Occupant could not verify whether the leak was still active.

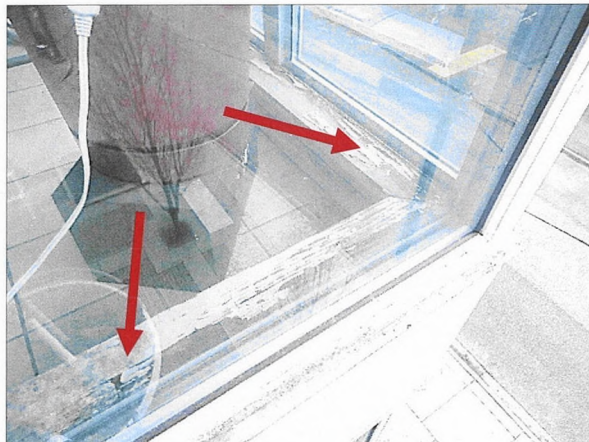
Photograph 62: Tower

The arrows point to decay of the wood stool plate at the window sills (North elevation, Level 4). The source of moisture is likely condensation on the interior side of the window frames.

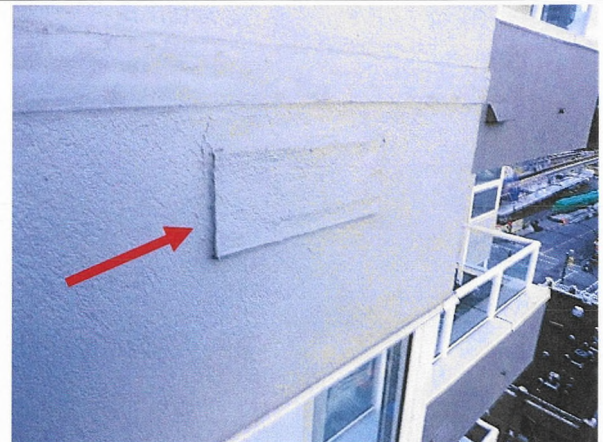
Photograph 63: Tower

The arrow points to a vent hood that was previously removed (by other parties) at the South elevation and the hole was sealed. The reason for removing the vent hood is not known at this time.

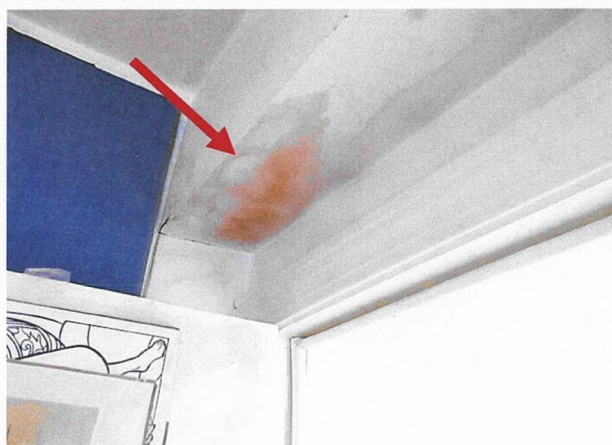
Photograph 64: Town Homes (#3376)

The arrow points to a large moisture stain on the ceiling of the room on the main floor (nearest the North elevation). The stain was not wet at the time of MGH's site visit.
