AFFIDAVIT

STRUCTURAL SITE REPORT

Project Name: 3362-3384 Vanness Avenue

Date: October 1, 2024

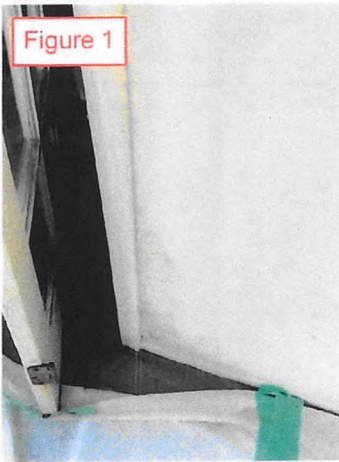
Figure 1

- Unit 3376 displayed multiple areas with mold growing through the carpet and drywall (Figures 1-3, Figure 12).
- The front room on both levels of the stacked townhouse structure(s) displayed signs of significant organic growth and decay on multiple structural members and plywood sheathing (Figures 4-11).

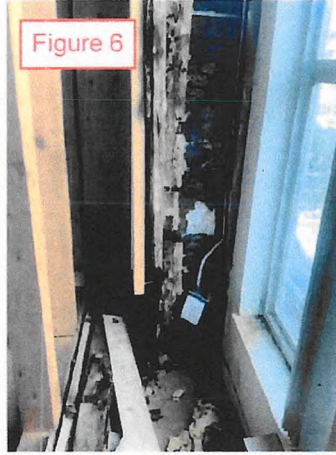
Figure 6

- Multiple posts were observed with over 50% of the section missing through decay (Figure 6, Figure 9).
- The remaining occupied seven units had small sections of drywall previously cut during the building envelope investigation. This allowed limited review of the structural framing system as plastic sheeting and insulation remained in multiple locations (Figures 20-23).
