AFFIDAVIT

STRUCTURAL SITE REPORT

Project Name: 3362-3384 Vanness Avenue

Date: October 1, 2024

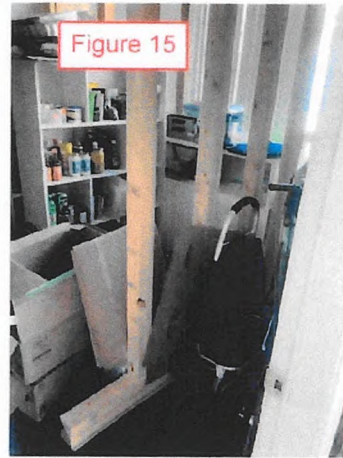
Figure 15

A previous building envelope review had noted multiple units to be under high-risk. Unit 3376 had previously been boarded up prior to the GS review. All units were provided with temporary shoring systems on both the main and upper level, reflecting deteriorated base building framing capacity. Particularly, shoring was located inside the front window(s) where the water damage and decay was previously observed (Figure 15). Some observations of note:

Given that exposed framing in Unit 3376 displayed significant signs of structural deterioration and the remaining units showed similar signs of moisture, organic growth, and decay within the wall framing systems, Glotman-Simpson recommends vacating the premises. Notwithstanding there is shoring framing in these units that forestalls failure of the observed framing, it is not clear that this shoring is adequate, nor provided in all in areas with visible mold and deterioration. Areas of visible mold and water ingress are extensive. Remediation, if possible, would need to be undertaken in hazardous working conditions and would require the removal of finishes along the building fronts, as well as at a depth of several feet from the front facade. Shoring walls would need to relieve all load from this portion of the building frontage prior to work progressing. Facilitating this work in an occupied building, with hazardous materials is not possible with occupants living in the units.

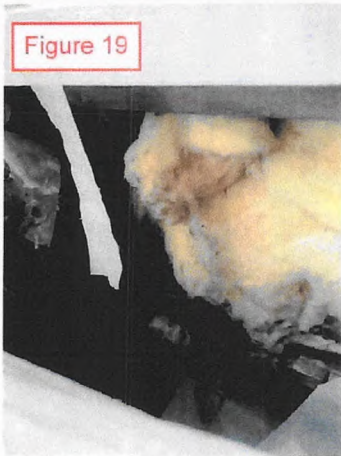
Figure 19

- Several locations did indicate signs of decay and organic growth on wooden framing members within the wall (Figures 19, 24, 35).
- Window sills displayed signs of decay with cracked wooden framing and organic growth. A few locations appear to have mold growing/moisture within the insulation (Figures 26-28, 36), with another location appearing to have mold growing through the drywall (Figure 22).
