NO. S-246230  
VANCOUVER REGISTRY

**IN THE SUPREME COURT OF BRITISH COLUMBIA**

**AFFIDAVIT**

7. Attached hereto and marked as **Exhibit "A"** to this affidavit is a true copy of a targeted structural assessment I prepared and issued following a site visit on June 17, 2020 to assess the structural deterioration of the Townhomes, dated June 25, 2020.

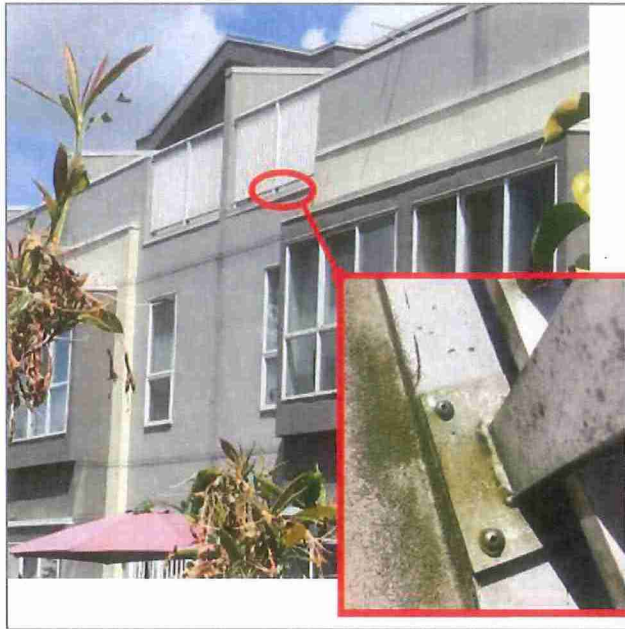
Figure 8

Contrary to current best practices, guardrail posts are top mounted to the horizontal deck surfaces, as shown in Figure 8. Current practice is to side-mount guardrail posts because top mounted posts are susceptible to water ingress through the penetrations.

Typical deck guardrail top mounted post. Top mounted posts are more susceptible to water ingress than side mounted posts.

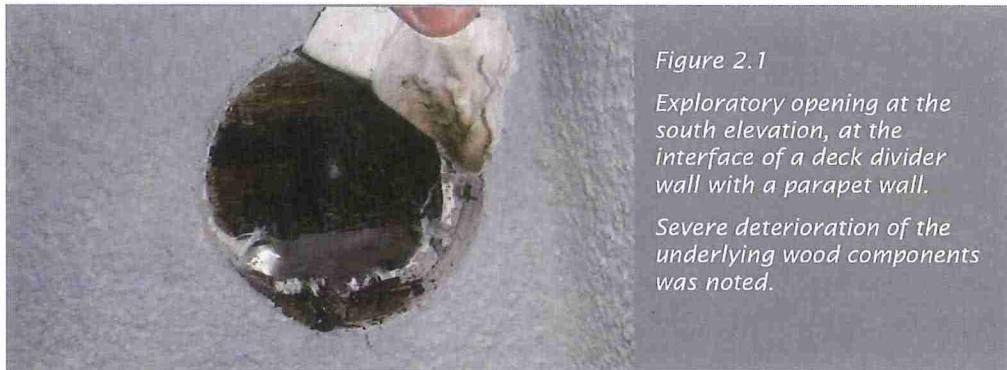
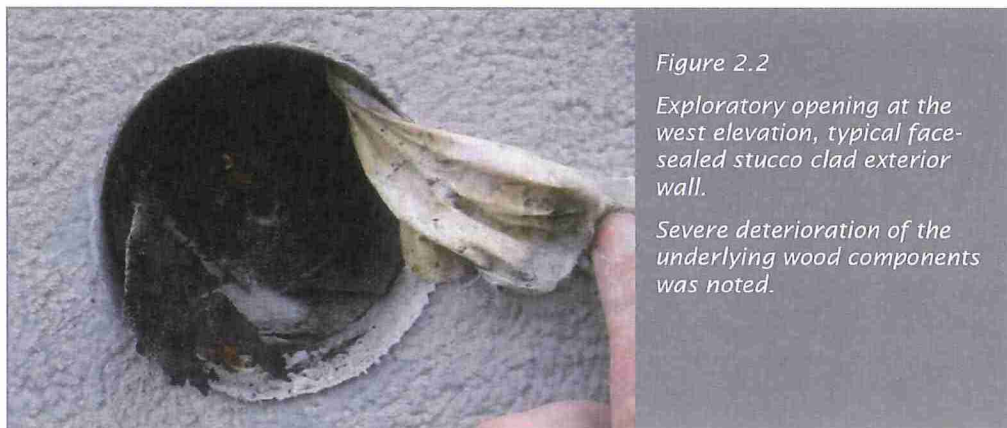
Exploratory openings were made to confirm the underlying condition of concealed framing components at the townhouse building. Deterioration of the underlying components was noted at the east, south, and west elevations. RDH made 15 exploratory openings at exterior walls as part of the additional investigation. Evidence of moisture and/or water ingress was noted at all 15 openings. Additionally, severe deterioration of the wood sheathing and/or underlying framing was noted at 14 of the 15 exploratory openings. Photographs of the exploratory openings are included in Appendix A.

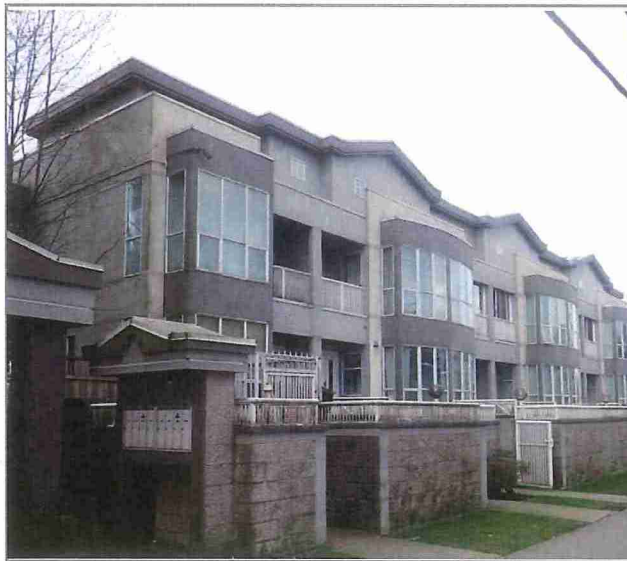
*Figure 3.1*

Face-seal wall assemblies are intended to deal with exterior moisture in the form of rain by sealing the exterior of the wall and preventing any water from penetrating past the outer seal. The intention is to stop water at the outer face of the cladding. If water does penetrate past the cladding, it cannot readily drain out of the wall. Water trapped in the assembly can damage moisture-sensitive materials, such as the wood framing; it is therefore essential to ensure that water does not penetrate the outer cladding.

*Typical exterior walls at Joyce Place townhouses are classed as face-sealed assemblies.*

This water management strategy can work in certain conditions where the wall is in a protected location and receives little exposure to wetting. However, in most situations, face-sealed walls do not perform well in our climate. This is primarily because it is extremely difficult to effectively seal the exterior cladding and ensure that no water will enter.

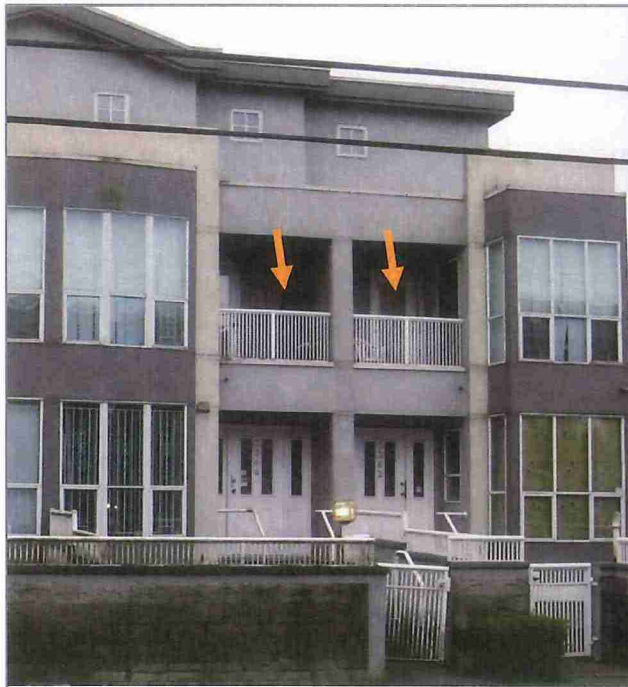
*Figure 3.6*

Based on the findings from the earlier RDH targeted structural investigation, there are areas of deterioration at/or adjacent to wood-framed balconies at the north elevation of the Joyce Place townhouses.

*Balconies at the north elevation of the Joyce Place townhouses are marked with arrows.*

The balconies are currently protected with a vinyl membrane. In order to access the underlying wood components, removal of the membrane and the balcony sheathing will be required to implement structural repairs. Following the implementation of structural repairs and installation of new plywood balcony sheathing, new vinyl membranes should be installed.

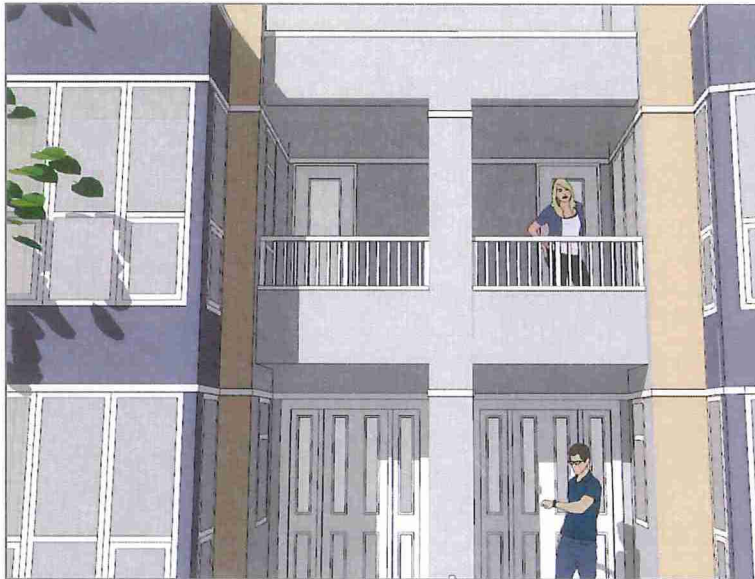
*Figure 3.8*

*The existing condition with a combination of guardrails and stucco clad guard walls could be reproduced during rehabilitation; however, there are benefits to other approaches.*

- As part of the rehabilitation process, guard walls will have to be rebuilt. Water ingress has occurred at these locations and has resulted in damage to underlying sheathing and wood framing. The repair process is expensive as is the application of new rainscreen stucco cladding and new flashings.
- Structural upgrading of balconies may require the full removal and rebuilding of the guard walls adding an additional expense.
- Use of new aluminum-framed guardrails is more cost effective and will result in an additional 6" to 8" of balcony space at the edge.
- Visually, new guardrails could enhance the appearance of the building, particularly on the north elevation, by reducing the extent of stucco cladding.

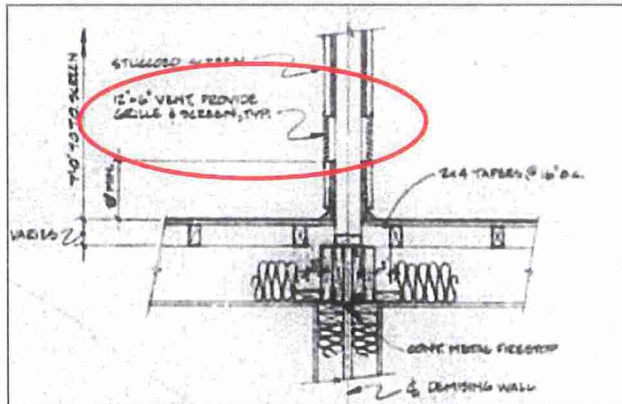
Figure 3.16

The existing deck assembly is a vented assembly. Ventilation for the existing deck assembly is provided by means of cross-ventilation between the wood joist framing of the current assembly, formed by tapered pieces of wood installed across the top of the joists. The outlet for this natural ventilation configuration is typically located at the vent grilles visible at the privacy walls between deck assemblies (Figure 3.16 and Figure 3.17).

Partial view of section detail L on sheet A10 of the architectural drawings.

Exhaust grille for the ventilation system of the existing deck assembly is circled.

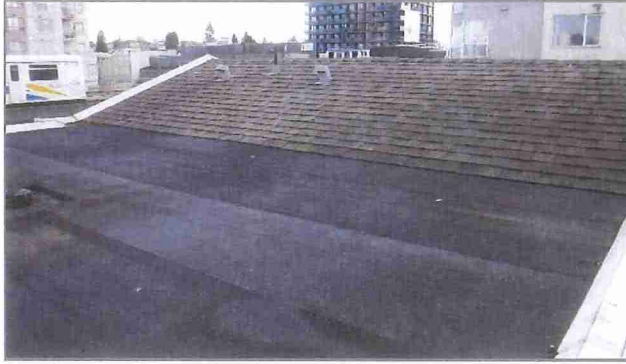
*Figure 3.22*

*View of existing low-slope membrane roof (flat roof) and sloped roof assembly at the main roof area above level 3.*

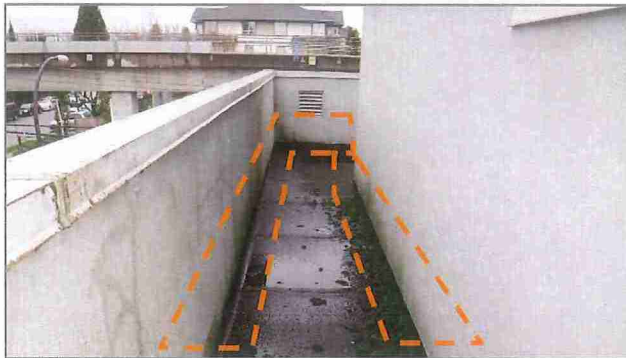
*Figure 3.23*

*Partial view of flat roof at level 3, west elevation. Approximate extent of tie-ins of the level 3 flat roof to the level 3 base of wall are marked with dashed lines.*

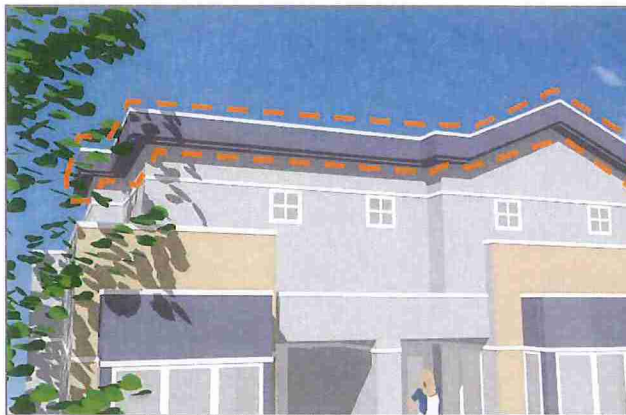
*Figure 3.24*

*Approximate extent of perimeter tie-in of main roof to be rehabilitated at level 3 top of wall areas is marked with a dashed outline on snapshot of 3D model.*

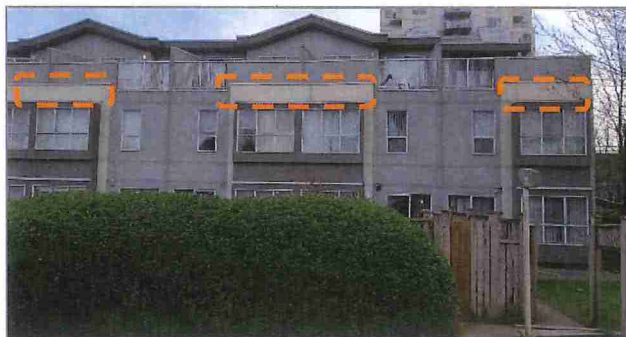
*Figure 3.25*

*Partial view of south elevation with locations of metal roof assemblies outlined.*

Metal roof assemblies at the south elevation of level 3 are proposed to be rehabilitated with an exterior insulated standing seam metal roof assembly. Standing seam metal roof assemblies are considered very durable roof assemblies and will allow for the installation of continuous exterior insulation below the metal roofs to achieve the energy performance requirements in the Vancouver Building By-law.

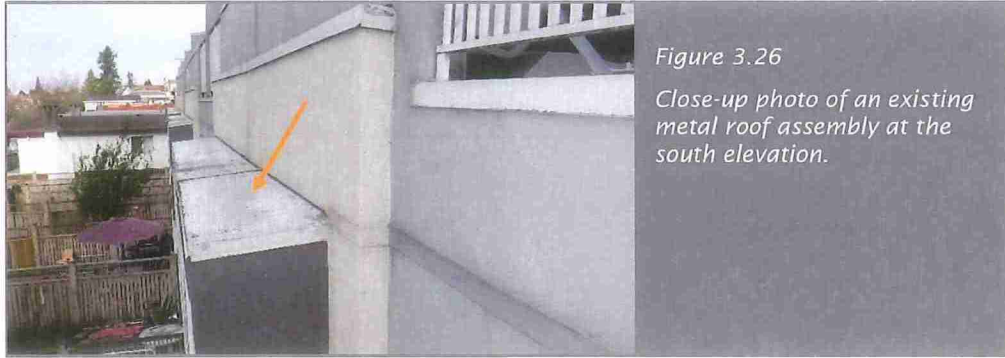
Figure 3.26

Close-up photo of an existing metal roof assembly at the south elevation.

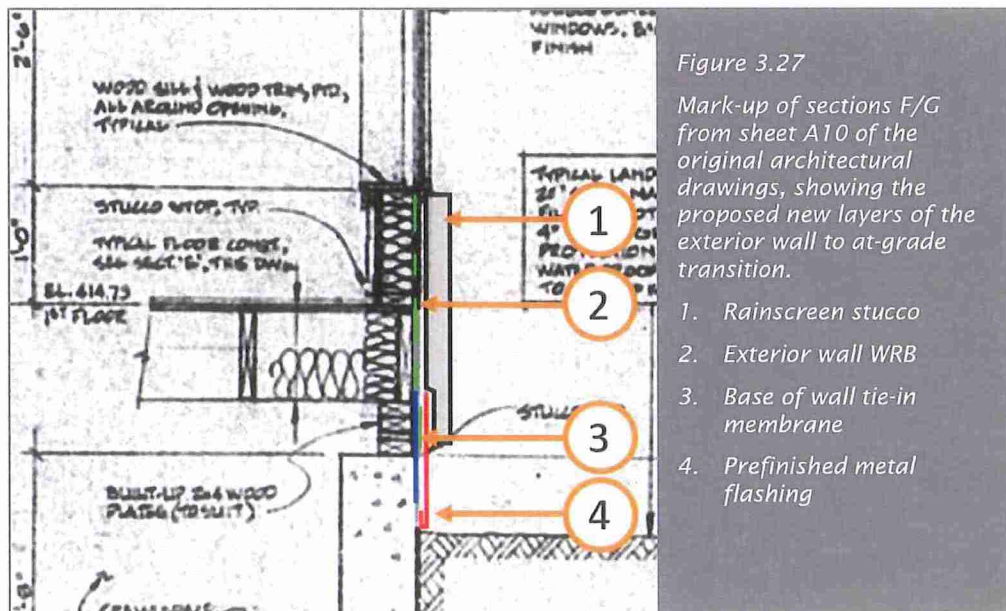
Figure 3.27

Mark-up of sections F/G from sheet A10 of the original architectural drawings, showing the proposed new layers of the exterior wall to at-grade transition.

A tie-in detail between the base of wall weather resistive barrier (WRB) at the joint at the transition between wood framing to the crawl space concrete wall is proposed. Existing ventilation within the crawl space is to be maintained. The base of wall will typically be protected with a prefinished metal flashing (Figure 3.27).

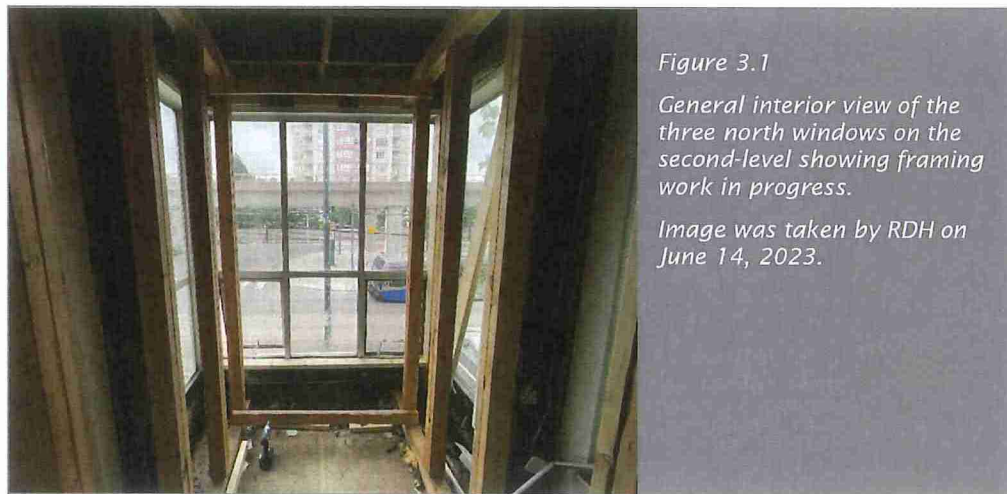
*Figure 3.1*

The three north windows on the second-level of Unit 3376 were no longer supported by the wall framing due to significant wood deterioration around the window openings. Steelhead was instructed to install plywood sheathing covering both the interior and exterior sides of the windows to prevent the windows from detaching from the building in the event of a significant windstorm.

*General interior view of the three north windows on the second-level showing framing work in progress.*

On June 14, 2023, RDH attended Unit 3376 to review the work progress. At the time of our visit, Steelhead was in the process of constructing a new 2x4 frame on the interior side of the window to support the interior plywood sheathing. The 2x4 frame was fastened to the adjacent floor joists and top plates. The installation ongoing at the time of RDH's site visit was proceeding satisfactorily. RDH requested photo documentation of the completed work for review purposes.

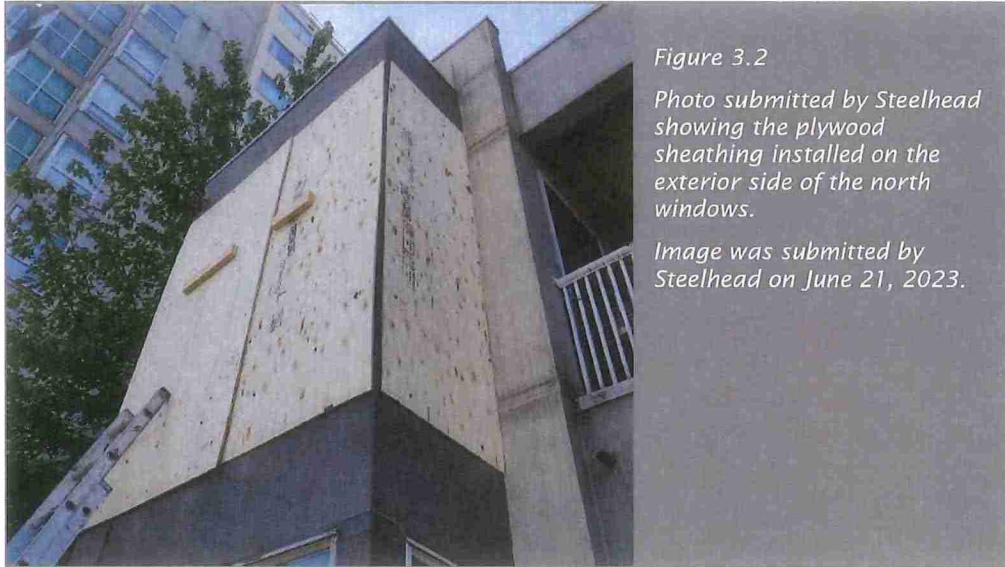
*Figure 3.2*

Steelhead submitted photos of the completed work on June 21, 2023, for RDH's review. Refer to Figure 3.2 below for example. Based on our site review and a review of Steelhead's photo, we are in the opinion that the window reinforcing was satisfactorily completed.

*Photo submitted by Steelhead showing the plywood sheathing installed on the exterior side of the north windows.*

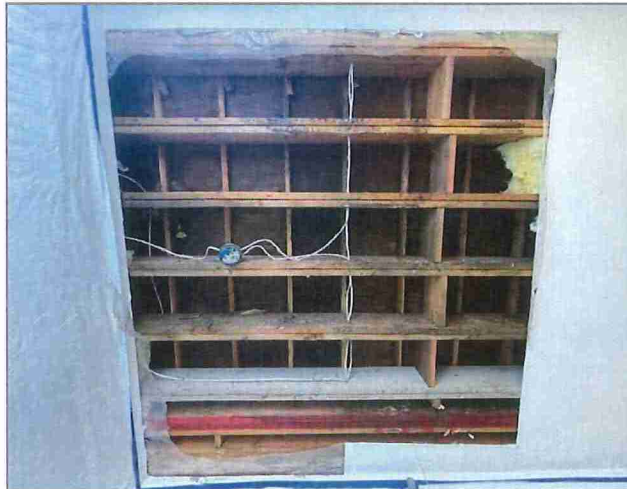
*Figure 3.3*

On August 25, 2023, Steelhead returned to Unit 3376 to prepare an exploratory opening in the room below the third-floor deck. Steelhead removed a section of the drywall ceiling (approximately 8 feet by 8 feet) and the insulation to expose the wood framing for review (Figure 3.3). RDH observed staining, organic growth, and localized deterioration of the plywood deck floor sheathing. The existing plywood sheathing was compromised and should not be relied on to support resident's use of the deck.

*General view of the third-floor deck framing (underside) from the room below.*

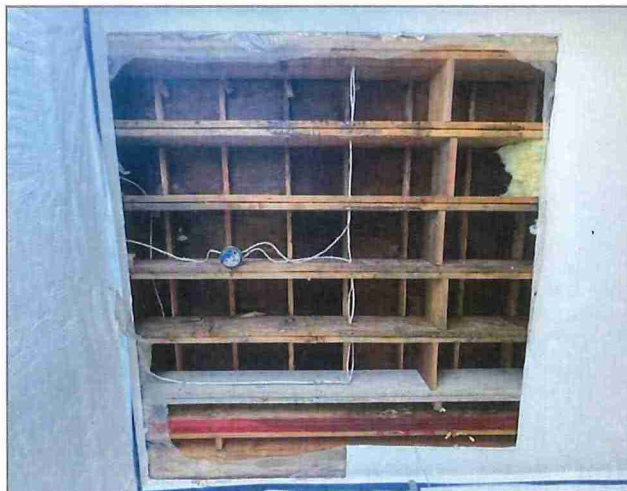
*Figure 3.5*

On June 14, 2023, RDH attended Unit 3372 to review the exploratory opening prepared by Steelhead in the room below the third-floor deck. Steelhead removed a section of the drywall ceiling (approximately 8 feet by 8 feet) and the insulation to expose the wood framing for review (Figure 3.5). RDH observed staining, organic growth, and significant deterioration of the existing plywood sheathing at several locations (Figure 3.6). The existing plywood sheathing was compromised and should not be relied on to support resident's use of the deck.

*General view of the third-floor deck framing (underside) from the room below.*

*Unit 3372.*

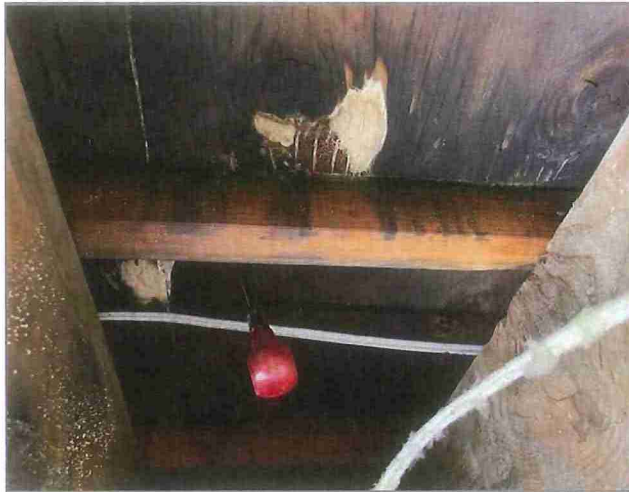
*Figure 3.6*

*Close up view of the underside of plywood sheathing with significant deterioration.*

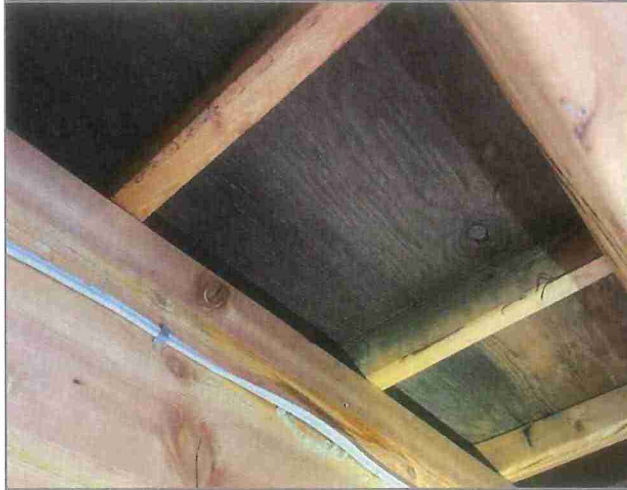
*Figure 3.8*

On August 25, 2023, RDH attended Unit 3366 to review the exploratory opening prepared by Steelhead in the room below the third-floor deck (Figure 3.7). RDH's observations at this exploratory opening were generally consistent with our observations at Unit 3372 and Unit 3376. The existing plywood sheathing showed evidence of deterioration and should not be relied on to support resident's use of the deck (Figure 3.8). However, the existing 2x10 wood joists were generally free from significant deterioration and their structural integrity was not significantly compromised.

*Close up view of the underside of plywood sheathing showing staining and deterioration.*

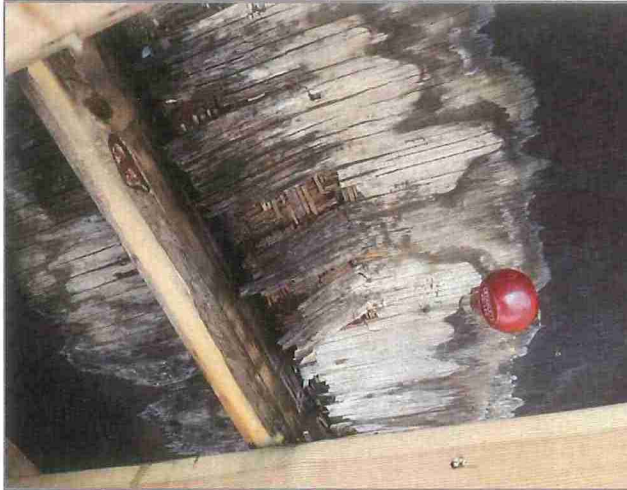
*Figure 3.10*

On August 28, 2023. RDH attended Unit 3364 to review the exploratory opening prepared by Steelhead in the room below the third-floor deck (Figure 3.9). RDH observed staining, organic growth, and significant deterioration of the existing plywood sheathing (Figure 3.10). The existing plywood sheathing was compromised and should not be relied on to support resident's use of the deck.

*Close up view of the underside of plywood sheathing showing staining and deterioration.*

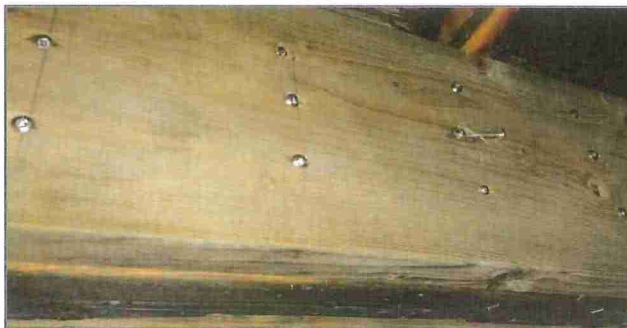
*Figure 3.12*

*Close up view of the pressure treated 2x10 sistered to the side of the damaged joist.*

*Unit 3364. Image was submitted by Steelhead on September 6, 2023.*

Localized staining, organic growth, and deterioration was observed on one of the double 2x10 wood joists that support the third-floor deck (Figure 3.11). The structural capacity of this damaged double 2x10 joist had been reduced which necessitated repairs. RDH provided repair instructions to Steelhead in the form of site sketches and verbal instructions. The repair involved applying preservative treatment to the existing damaged wood joist and sistering a new pressure treated 2x10 to the side of the damaged joist.

Steelhead completed a structural repair the following day, August 29, 2023. Photos of the completed work were submitted to RDH on September 6, 2023, for review. Refer to Figure 3.12 below for example. Steelhead's photos indicated that the repair was completed in general accordance with site instructions.

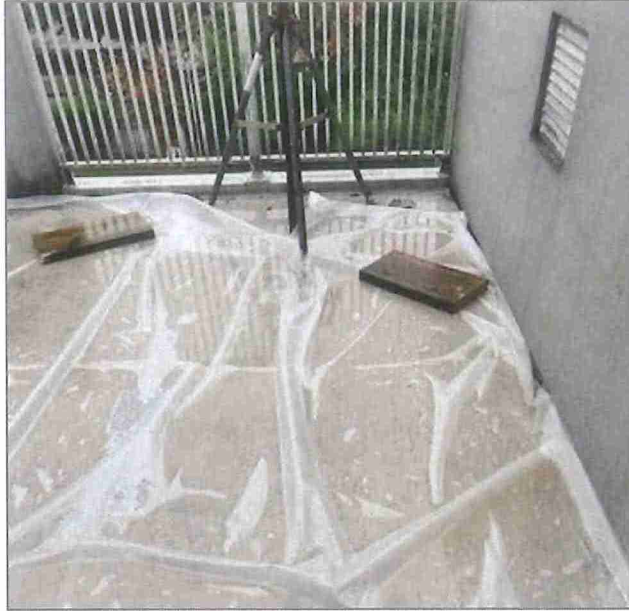
*Figure 3.13*

While performing the joist repair at Unit 3364, Steelhead reported active water ingress at the third-floor deck during a rainy event (Figure 3.13). This was attributed to membrane deficiencies on the deck and tripod fasteners penetrating the deck membrane. Steelhead installed a temporary tarp to help protect the deck area; however, this measure will not address the water ingress issues.

*General view of the third-floor deck above the exploratory opening.*

To mitigate the risk of continued structural deterioration, the Owners should complete membrane repairs, as noted in our previous report.

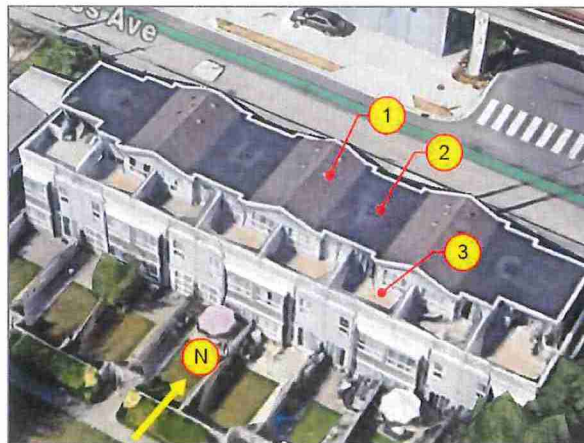
Figure 1.1

Aerial view from Google Maps

Third floor decks (Item 3 - Figure 1.1), at seven of eight units were assessed for structural damage caused by ongoing leakage of deck membranes. Access to 3362 was not available at the time of our site visit. Membrane discontinuities and indications of water damage were observed at all seven accessed units. Occupants of all units were reminded not to access their third-floor decks.

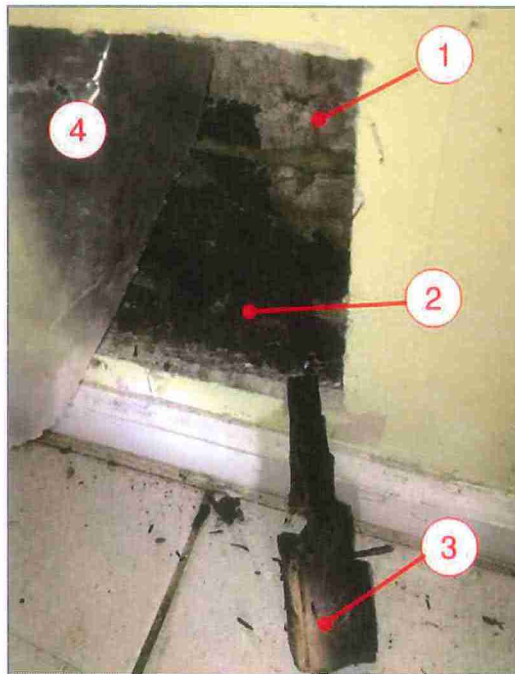
*Figure 1.2*

At many of the observation openings, particularly at the north walls, wall cavity components were very wet, and structural components were deteriorated to the point where their ability to support structural loads was questionable. Localized areas of plywood sheathing were completely deteriorated.

*Photo taken on June 17, 2020.*

- 1) Interior surface of sheathing paper. The sheathing paper, which is on the exterior surface of the plywood sheathing, is visible because the plywood sheathing has deteriorated.*
- 2) Deteriorated plywood sheathing.*
- 3) A section of deteriorated wood stud that removed from the EO.*
- 4) Polyethylene vapour barrier*

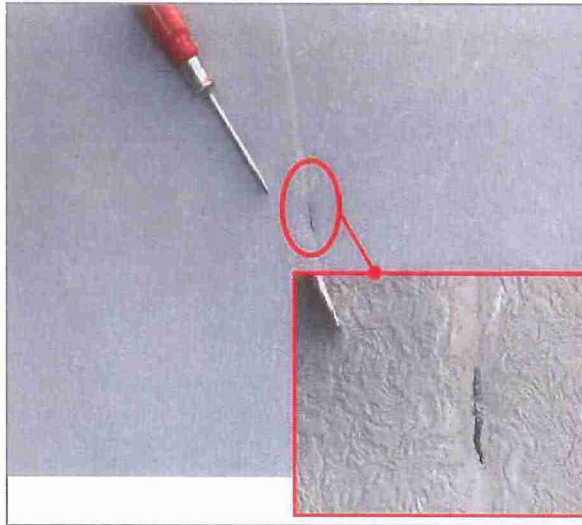
*Figure 1.3*

At all of the reviewed third-floor deck membranes, discontinuities at membrane seams were observed – refer to Figure 1.3 for example. The deck membrane at 3370 had been patched, and it was apparent that the sheathing beneath the patch had deteriorated to the point that it could no longer support pedestrian traffic – refer to Figure 1.4.

*Photo taken on June 17, 2020.*

*Third-floor deck at 3368 with membrane discontinuity at seam. Similar observations were recorded at other third-floor decks.*
