IN THE SUPREME COURT OF BRITISH COLUMBIA

BUILDING ENVELOPE CONDITION ASSESSMENT REPORT

DATE:
 January 3, 2017

PROJECT: Joyce Place - Strata Plan LMS 992
Building Envelope Investigation

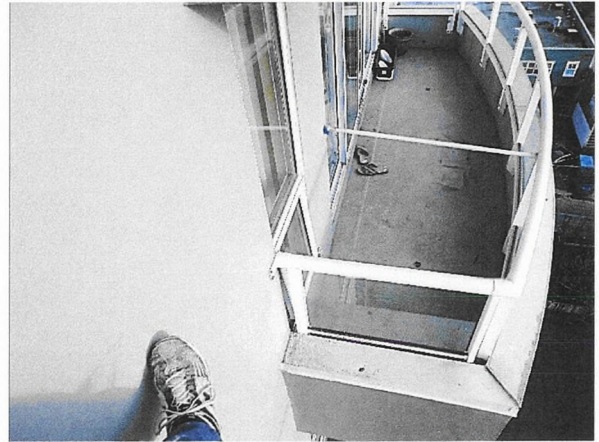
Photograph 12: Tower
Closer view of a typical outdoor balcony (South elevation). See **Photograph 11**.

8.1.5	<p>Balconies:</p> <ul style="list-style-type: none"> a. The waterproof / traffic coating on the top side of the balconies generally appear in good condition based on the visual review of the balconies during the bosun's chair drops. See Photograph 12.

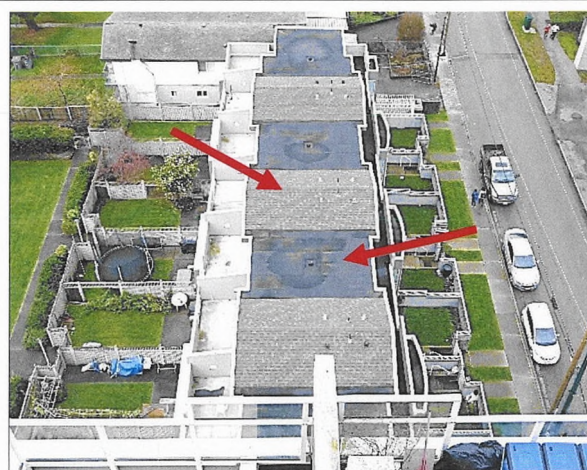
Photograph 18: Town Homes

The left arrow points to a "pitched" roof. The right arrow points to a "flat" roof.

8.2.5	<p>Summary of Findings (Continued)</p> <p>Roofing:</p> <ul style="list-style-type: none"> a. The roofing membrane at the upper roof and lower flat roof generally appear in good condition b. A large area of standing water is visible surrounding the roof drain on the flat roofs (See Photographs 18 and 19). The water is not able to fully drain towards the roof drain. c. MGH recommends that the Strata Corporation authorize a roofing contractor to review the roof drain and the roof slope, and to verify the location of the roof drain relative to the low point on the flat roof.

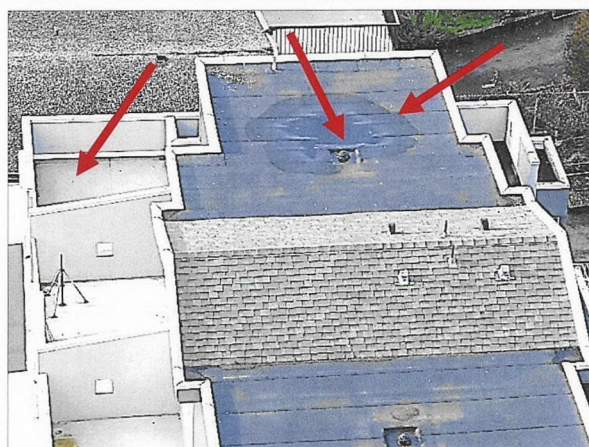
Photograph 19: Town Homes

Closer view of the roofing shown in **Photograph 18**. The left arrow points to a typical outdoor deck at floor level 3. The middle arrow points to a typical roof drain. The right arrow points to the outline of a large area of standing water.

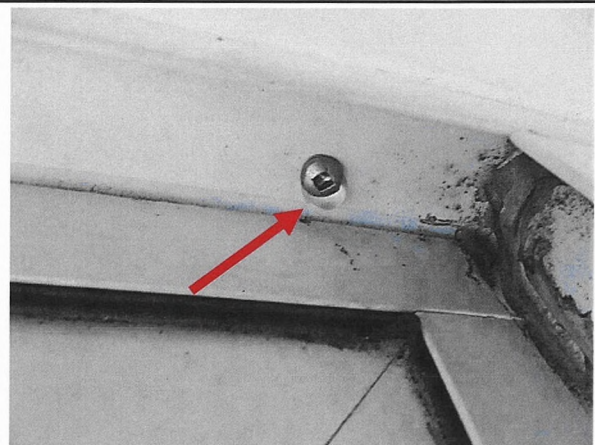
Photograph 33: Tower (#502)

The arrow points to a large water droplet during an active leak at the head of the window frame. Many of the screws are severely corroded at this window and other windows in Unit #502.

The arrow points to a corroded screw that anchors the window frame to the building. Water actively leaks through these screw holes. See **Photograph 33**.

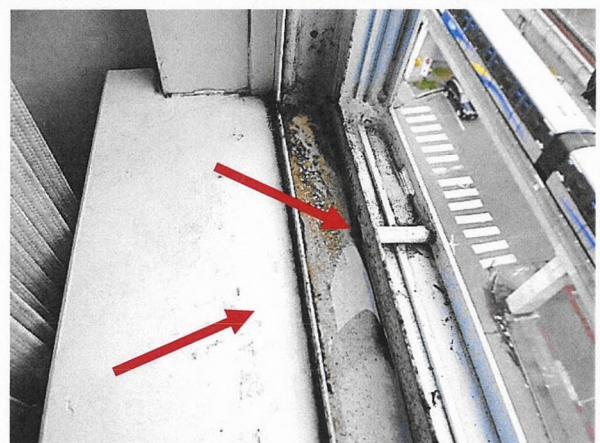
Photograph 37: Tower (#901)

The left arrow points to water overflowing the top edge of the trough and spilling onto the wood stool plate. The right arrow points to a clogged weep-hole which prevents drainage of water accumulating in the trough.

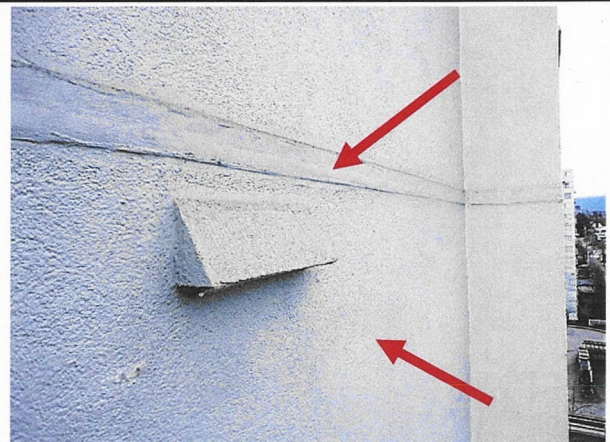
Photograph 41: Tower

8.1.2	<p>Summary of Findings (Continued)</p> <p>Cladding:</p> <p>a. MGH was informed that all exterior surfaces of the stucco cladding were previously renewed with a new waterproofing coating in year 2014. The coating appears to be a silicone elastomeric product "AllGuard" as manufactured by Dow Corning. The coating generally appears in good condition. See Photograph 41.</p> <p>b. It is the opinion of MGH that when such coating products are applied to an existing face-sealed stucco cladding the intended function of the coating is to maintain the continuity of the "face-seal" of the existing stucco cladding. However, the design of the exterior cladding assembly still remains as a "face-seal" which cannot manage, drain, and/or discharge exterior water (i.e., wind-driven rain) that may penetrate the face-seal of the stucco cladding. The AllGuard coating will still require continued diligent periodic reviews and maintenance to prolong the life of the stucco cladding.</p> <p>c. It is the opinion of MGH that such coatings cannot serve to protect against moisture ingress into the wall cavity of an exterior wall when the source of moisture is water from condensation on the interior side of an exterior window. Water that accumulates at the base of a window (after repeated cycles of condensation) can potentially leak into the wall cavity below the window sill. It is the opinion of MGH that water from condensation is likely a significant source of moisture that has caused damage to the wood components surrounding the wall openings at windows.</p>

The lower arrow points to an example of the Dow Corning "AllGuard" silicone elastomeric coating on the stucco cladding. The upper arrow points to an example of the Dow Corning "123 Silicone Seal" strip applied over-top a previously caulked joint.

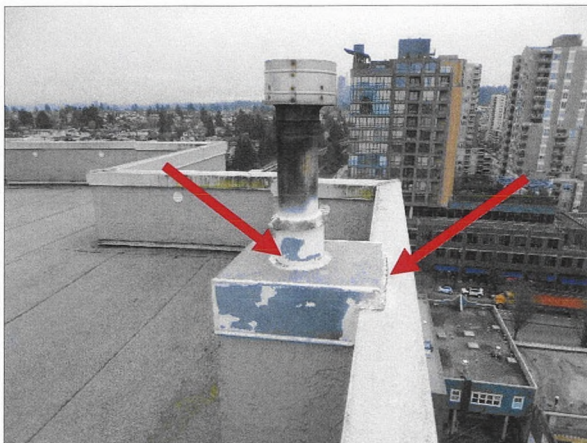
Photograph 42: Tower (Roof)
 The arrow point to caulking at joints. The caulking appears weathered.

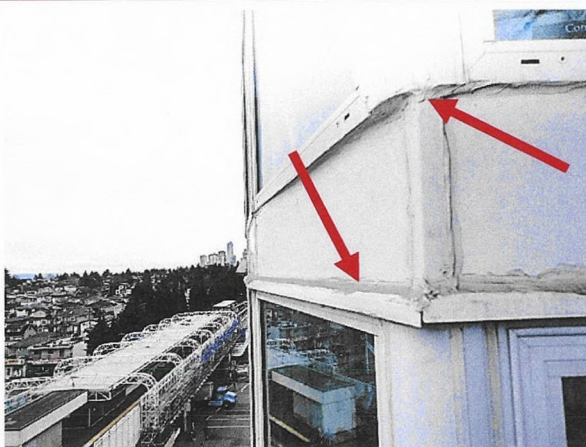
Photograph 44: Tower
 The arrow points to caulking at exterior joints of a typical metal panel. The caulking appears weathered.

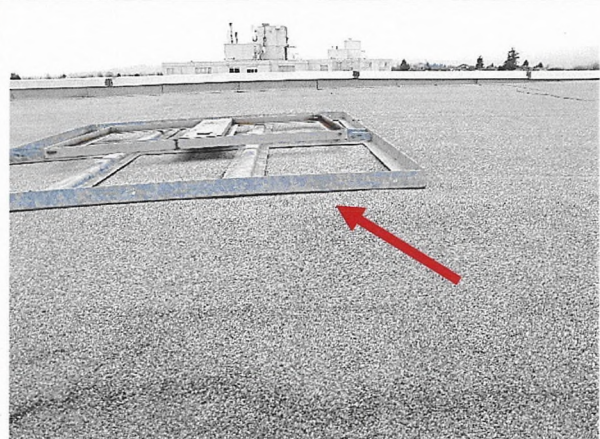
Photograph 45: Mechanical Penthouse
 The arrow points to metal debris on the rooftop.

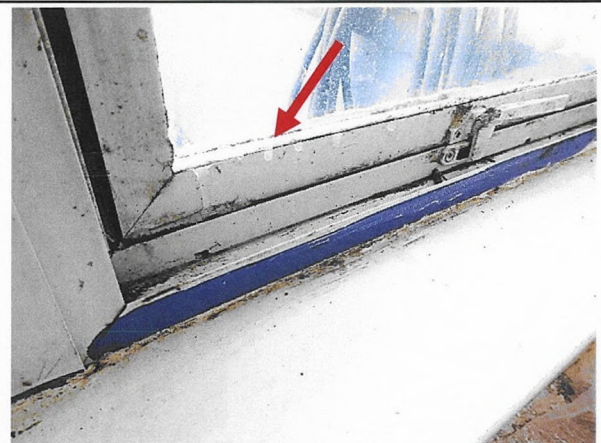
Photograph 49: Town Homes (#3372)

8.2.7	<p>Summary of Findings (Continued)</p> <p>Windows:</p> <ol style="list-style-type: none"> MGH observed severe condensation on the interior side of exterior windows at selected town homes. See Photographs 49 and 55. Condensation was not evident at every town home MGH visited, and the severity of condensation varied from town home to town home. The time of day when MGH visited the town homes did not coincide with periods of cooking nor periods of bathroom/shower use. The severe condensation resulted in: <ul style="list-style-type: none"> Large-sized water droplets hanging from the horizontal edge of the window frame along the window head (See Photograph 55). Water accumulating in the horizontal trough at the sill of the window frame. Mold / fungal growth on most of the surfaces surrounding the interior side of the window frame (i.e., the interior drywall, the wood stool plat at the window sill, window coverings, etc.) See Photograph 29.

The arrow points to large water droplets originating from condensation on the window frame. This water is likely the source of moisture causing the damage shown in **Photograph 48**.

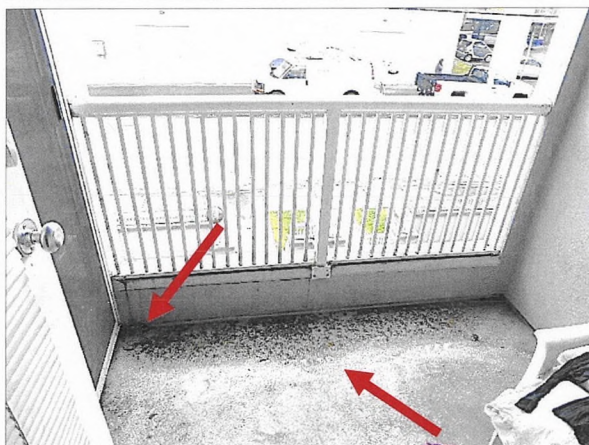
Photograph 54: Town Homes

8.2.6	<p>Balconies:</p> <ul style="list-style-type: none"> a. MGH reviewed the outdoor balconies (facing North) at the town homes it visited. b. MGH observed standing water at the front (outside) corner of the balcony floor, adjacent the balcony drain hole. c. The balcony drain is a pipe that penetrates the bottom corner of balcony guard wall. d. The balcony floor does not properly slope towards the drain pipe, and the low point on the balcony floor does not coincide with the location of the balcony drain. As a result, standing water on the balcony floor (from rain and melting snow) accumulates near but does not completely drain out through the hole in the guard wall. See Photograph 54.

View of a typical balcony at the North side of the town homes. The left arrow points to the balcony floor drain (i.e., a hole through the guard wall). The right arrow points to the outline of a large area of standing water.

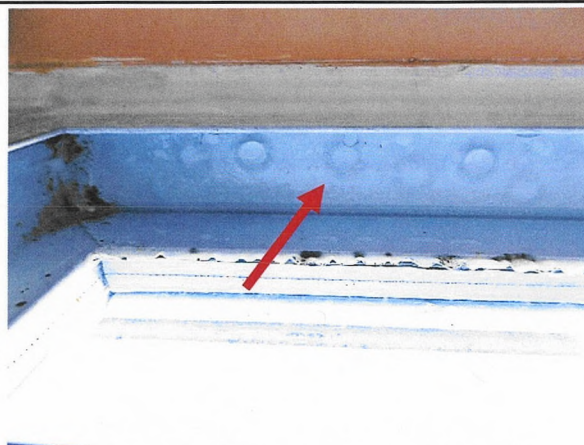
Photograph 55: Town Homes (#3364)

The arrow points to large water droplets originating from condensation along the head of the window frame.

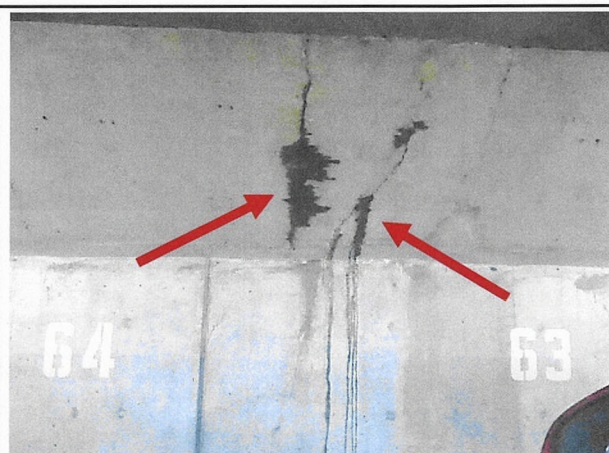
Photograph 57: Parkade

<p>Summary of Findings (Continued)</p> <p>Parkade:</p> <p>8.3.1 Active Leaks:</p> <p>a. MGH observed active leaks through the parkade roof slab, and through the parkade foundation wall (See Photographs 56 and 57).</p> <p>8.3.2 Catch Pans/Trays:</p> <p>a. Metal pans/trays have previously been installed (by other parties) at selected locations along the underside of the parkade roof slab to capture water leaking through the concrete slab. Pipes attached to the pans/trays redirect water from the tray and discharge the water onto the parkade floor (See Photograph 58).</p> <p>b. The trays capture water to prevent water splashing onto parked vehicles, but the trays do not address or prevent a more important issue which is that water can still penetrate the cracks/voids at the top-side of the parkade roof slab. Water that penetrates such cracks in concrete can wet the reinforcing steel embedded in the concrete slab. Repeated cycles of wetting the embedded reinforcing steel has the potential to corrode the reinforcing steel.</p> <p>8.3.3 Repair Strategy:</p> <p>a. MGH recommends a longer-term repair strategy that addresses sealing the cracks in the concrete (from the top side of the parkade roof slab) to prevent water contacting the reinforcing steel embedded in the slab.</p> <p>b. Applying a new waterproof coating or membrane on the top side of the parkade roof slab is preferable to injecting a sealant into the cracks in the concrete from the underside of the parkade roof slab. Injecting a sealant into the underside of a crack does not ensure that the sealant penetrates the full depth of the crack. There still remains a risk that water may penetrate the top half of a crack that was not sealed the full depth of the crack.</p> <p>c. Applying a new coating / membrane to the top side of the parked roof slab will also entail removing the existing soil over-burden and landscaping in order to expose and remove the existing waterproof coating on the top side of the parkade roof slab.</p>

The arrows point to active leaks through the foundation wall. South-East end of the parkade.

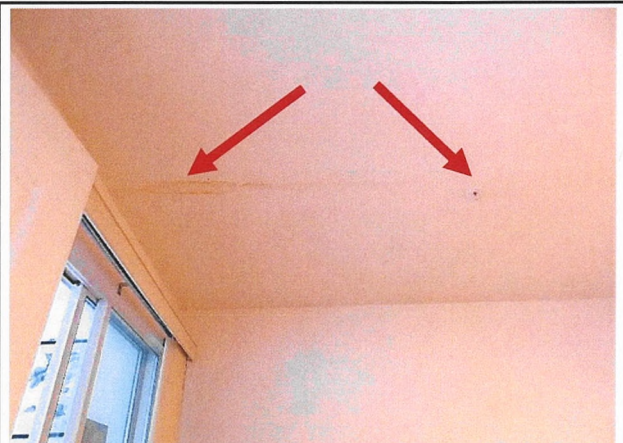
Photograph 61: Town Homes (#3376)

8.4.2	<p>Stains on Ceiling at Town Homes:</p> <p><u>TH #3376:</u></p> <p>MGH observed the following stains at the ceiling of the rooms at the upper floor:</p> <ul style="list-style-type: none"> a. A large circular stain surrounding the electrical junction box was not wet at the time of MGH's site visit (See Photograph 60). The Occupant could not confirm whether the leak was still active at this location. MGH recommends that the Strata Corporation coordinate with the Stata Owner / Occupant to monitor the stain on the ceiling and to verify whether the leak is still active at the electrical junction box. b. A lineal stain that extends between the fire sprinkler head and the sliding door was not wet at the time of MGH's site visit (See Photograph 61). The Occupant could not confirm whether the leak was still active at this location. MGH recommends that the Strata Corporation coordinate with the Stata Owner / Occupant to monitor the stain on the ceiling and to verify whether the leak is still active. If the leak is still active, a further investigation will be required to verify whether the source of moisture is related to the fire sprinkler head. <p>Note: MGH observed similar stains (adjacent to a fire sprinkler head) on the ceiling at other town homes at Joyce Place. MGH recommends that the Strata Corporation coordinate with the Strata Owner / Occupant at other town homes to verify whether there may be an active leak above the ceiling at those stains.</p>

The arrow points to a linear stain on the ceiling at an upper floor. The right arrow points to a fire sprinkler head. The stain aligns with the sprinkler head. The stain was not wet at the time of MGH's site visit.

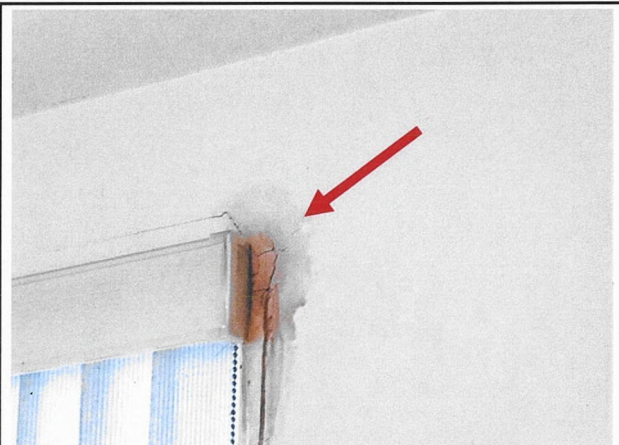
Photograph 65: Town Homes (#3376)

The arrow points to a large moisture stain on the wall of the room on the main floor (nearest the North elevation). The stain was not wet at the time of MGH's site visit.
